Reference: R.J. Bennett Homestead Bridge Inspection and Load Rating

STRUCTURE CONDITION INSPECTION REPORT

Inspected by:	Mike Unger, ASCT & Craig Mankey	Date:	August 13, 2019
Reviewed by:	Mike Unger, ASCT	Inspection Type:	Routine

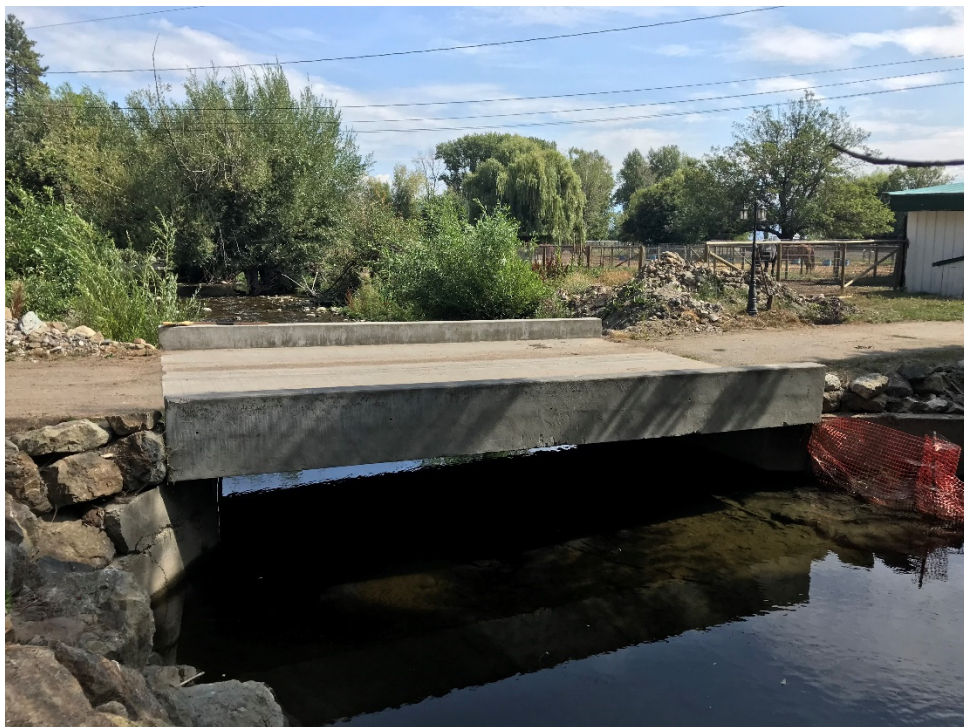
Figure 2: Bridge Elevation

The structure was found to be **INADEQUATE** to support the 21 tonne E31 Fire Truck. The governing structural member identified to be the Longitudinal Stringers under flexural demands due to the E31 vehicle.

Based on our findings, **we conclude that the structure is not suitable to carry the emergency response vehicle E31 and recommend that the City of West Kelowna Fire Rescue DO NOT use the proposed detour and private road as a possible emergency vehicle response route.**

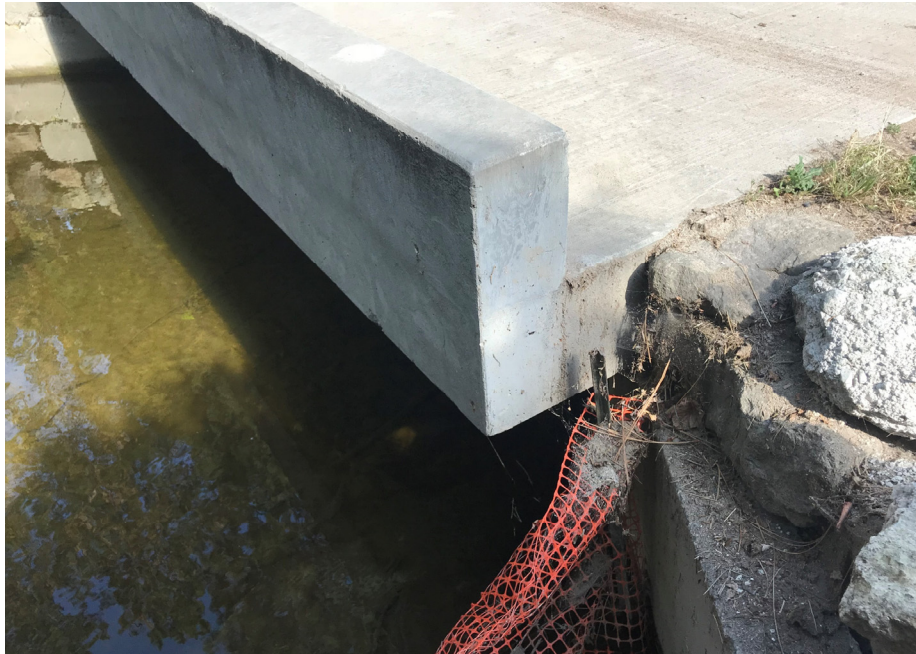
9 Footings/Pilings						100	No	Not inspected. Foundations are below ground/water level. No evidence of any problems.
10 Pier Col/Wall/Cribs							Yes	
11 Bearings		100					No	South exterior stringer not bearing on wingwall, as per original design.
12 Caps							Yes	
13 Corbels							Yes	
14 Dolphins/Fenders							Yes	
SUPERSTRUCTURE:								
15 Flr Beams/Transoms							Yes	
16 Stringers		100					No	Localized hairline/narrow cracks.
17 Girders							Yes	
18 Portals							Yes	
19 Bracing/Diaphragms		100					Yes	Localized hairline/narrow cracks.
20 Trus Chrds/Arch Ribs							Yes	
21 Arch Ties							Yes	
22 Truss Diagonals							Yes

South exterior stringer not bearing on east abutment

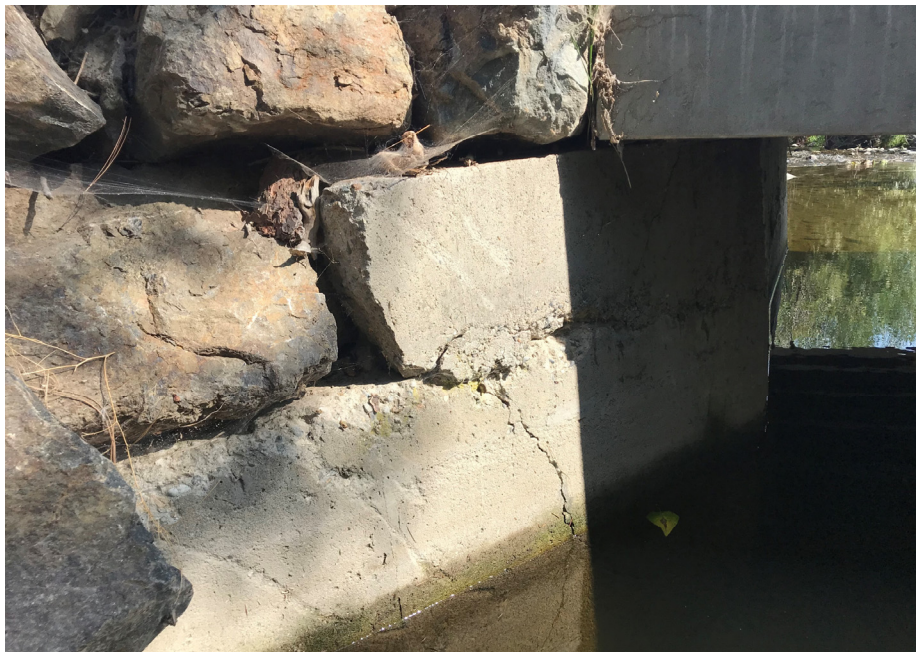
Southwest wingwall – note wide vertical crack and horizontal cold joint

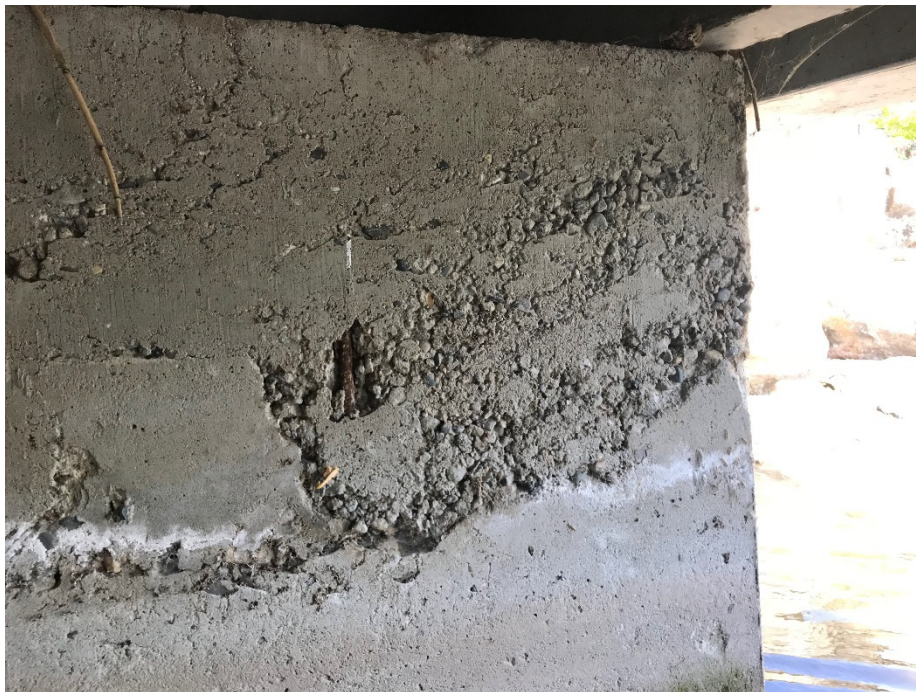
West abutment – honeycombing, exposed reinforcing

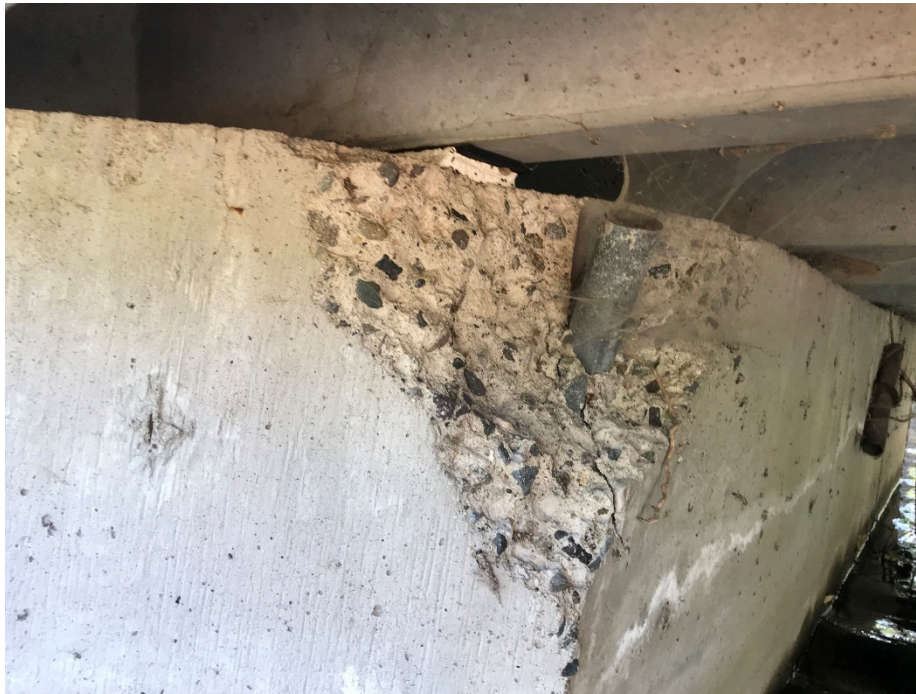
East abutment – spall with galvanized pipe

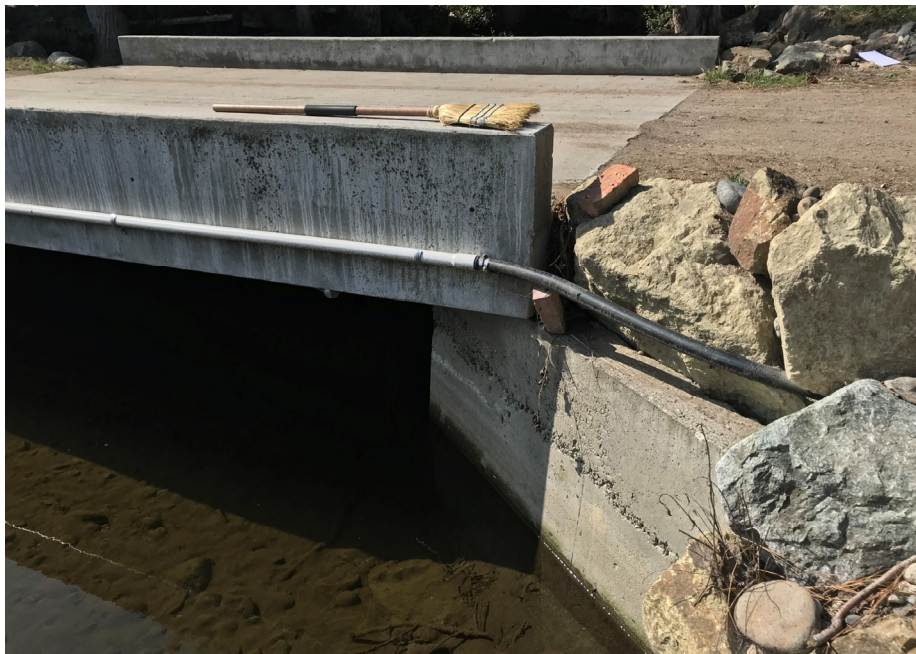
Northwest wingwall – cold joint and honeycombing
