COUNCIL REPORT
Development Services
For the May 28, 2019 Council Meeting

DATE: May 21, 2019 File: PRSTR20190177
TO: Jim Zaffino, CAO
FROM: Jason Sandberg, Development Engineer
RE: Application: Strata Building Conversion
Legal: Lot 1, DL 5057, Plan KAP41637
Address: 2311 Carrington Road
Owner: Sunlake Construction LTD.
Agent: Ron Knight, CFO Sunco Drywall LTD.

Brava Building 2

Building Condition Assessment

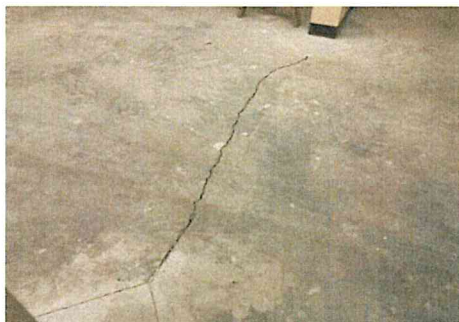
- Monitor crack in the concrete header over the west basement interior door.
- Monitor cracks in the slab-on-grade concrete for aesthetic changes / trip hazards.

<p>Slab-On-Grade. Crack Adjacent to Saw-Cut.</p>

Recommendation		Condition	Remaining Life	OPC
A1010.1 Foundation Condition. Monitor crack in header		Good	Greater than study extent	Less than Threshold
A1010.2 Slab-on-Grade. Monitor aesthetics / trip hazards due to cracks.		Good	Greater than study extent	Less than Threshold

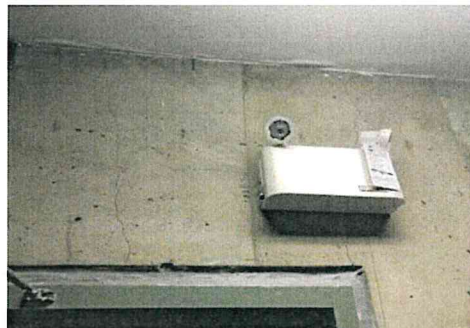
<p>Crack in Concrete Header Over West Interior Basement Door.</p></div>	<div><p>Description</p><p>Brava Building 2 includes a full below grade level. The perimeter foundation consists of cast-in-place, conventionally reinforced concrete walls bearing on strip footings. Interior and exterior columns bear on spread footings.</p><p>The basement floor is a concrete slab-on-grade.</p></div> <div><p>Assessment</p><p>No evidence of distress was observed. Minor cracking in the concrete was observed in a concrete header beam over the west basement interior door. The crack should be monitored for changes in crack width.</p><p>Some cracks were observed in the slab-on-grade. Cracks were adjacent to saw cuts, suggesting that saw cutting was completed after tensile stresses in the concrete had developed. Cracks are not a structural concern for a slab-on-grade and should be monitored for aesthetics/trip hazards.</p></div>

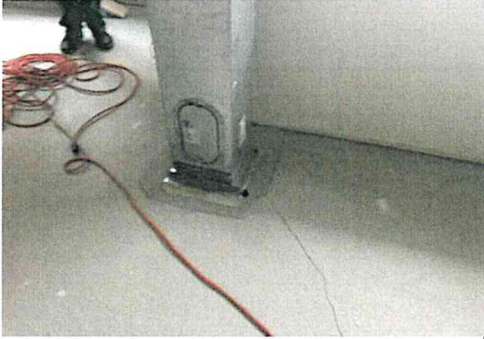
<p>Cracking in Ground Floor Concrete Topping.</p>	<p>Description</p> <p>The structure is wood-frame construction. Ground and upper floor framing consist of concrete topping on plywood sheathing on engineered wood joists spanning to wood beams and perimeter walls.</p> <p>Roof structure consists of sheathing on engineered roof trusses spanning to load bearing walls.</p> <p>Load bearing walls consist of 2x6 studs with wood headers at window and door openings. Walls are sheathed to provide lateral capacity.</p> <p>Roof overhangs at the south elevation of the ground floor and at upper floor balconies are supported on perimeter columns.</p> <p>Assessment</p> <p>Visual review of the superstructure found no evidence of distress. Superstructure framing is concealed by interior and exterior finishes and not directly visible.</p> <p>RJC observed some cracking in the concrete topping of the ground floor. It appears that the cracking is related to drying shrinkage and, in our opinion, is not a structural concern. The ground floor was un-finished at the time of RJC's review.</p> <p>Ground floor column caps are pressed concrete. Consideration should be given to application of a coating to prevent water ingress and improve long-term durability.</p>

RJC observed some cracking in the concrete topping of the ground floor. It appears that the cracking is related to drying shrinkage and, in our opinion, is not a structural concern. The ground floor was un-finished at the time of RJC's review.

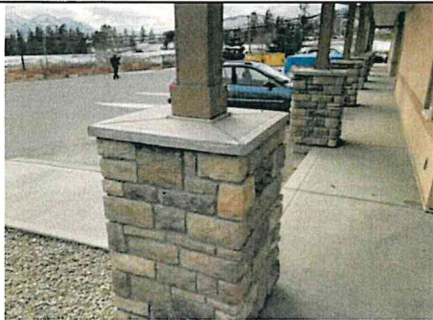
Column Caps, Ground Floor

- Replacement of three cracked IGUs.
- Installation of a protective coating to the ground floor column capitals to reduce incidence of water ingress.

Recommendation		Condition Remaining Life OPC
B1010.1	Add moisture protection to column caps to improve durability	<div>Good</div> Greater than study extent \$ 5,000.00

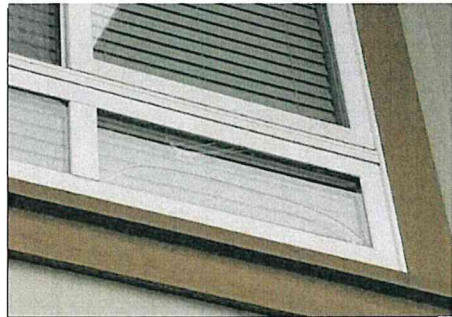
<p>Upper Storey Window with Cracked IGU. North Elevation.</p></div>	<p>Description</p> <p>Ground floor windows are double-pane sealed IGUs in aluminum frames. Specification of the frames is not known.</p> <p>Upper floor windows are double-pane sealed IGUs in vinyl frames. Specification of the frames is not known.</p> <p>Window installations were observed to have head flashings. Details of the head flashing installation were not visible for review.</p> <p>Assessment</p> <p>Windows and frames were generally found to be in good condition.</p> <p>We observed three window IGU units with cracked interior glazing panes. These IGUs should be replaced as part of regular building maintenance. All three are on the north elevation, two in the upper floor and one in the ground floor.</p>

Recommendation		Condition	Remaining Life	OPC	
B2020.1	Aluminum frames and windows.	Good	Greater than extent of study.	No Recommendations	
B2020.2	Vinyl frames and windows	Good	Greater than extent of study.	No Recommendations	
B2020.3	Replace three cracked IGUs	Failed	N/A	Maintenance

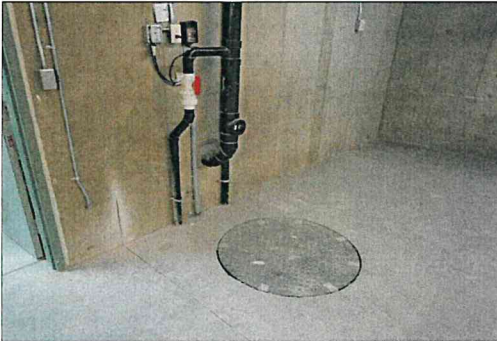
<p>Basement Floor Drain Sump and Sanitary Building Drain</p>	<p>Description</p> <ul style="list-style-type: none"> Plumbing fixtures appear to be original construction and have not been upgraded. Water distribution piping systems are comprised of Pex and PVC piping; sanitary systems are piped in ABS and condensate drainage systems are made of PVC. Sanitary drains in the basement are piped to a sump which lifts effluent to the main sanitary building drain. Domestic hot water heaters and fireplaces in the three residential suites are gas fired. Water and irrigation meters are located in the basement mechanical room. Cross contamination and premise isolation devices have not been provided on water service that is typically required by most municipalities. <p>Assessment</p> <ul style="list-style-type: none"> The domestic hot water tanks are nearing the end of their service lives and will likely need to be replaced in the near future. The sump pump is nearing the end of its service life and will likely need to be replaced in the near future. 									
<p>Recommendation</p> <p>D2010.1 Domestic hot water heaters - Replace as required. (Note: OPC is for each unit)</p> <p>D2010.2 Sump pump - Replace as required. (Note: OPC is for each unit)</p>

- Replace domestic hot water heaters when required. Estimated 1 year remaining service life.
- Replace the sump pump as required. Estimated 1 year remaining service life.
- Replace or repair split heat pump systems as required. Estimated 6-year remaining service life.
- Replace or repair split AC systems. Estimated 6-year remaining service life.
- Replace or repair electric baseboard heaters as required. Estimated 6-year remaining service life.

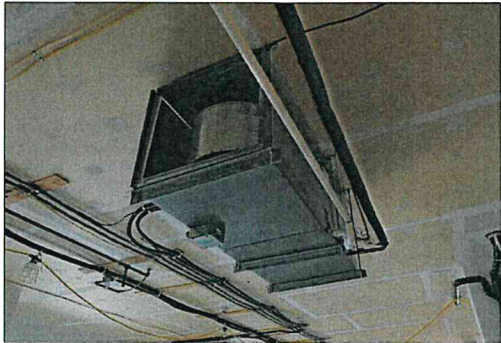
<p>Direct Expansion Fan Coil - Split Heat Pump System</p>

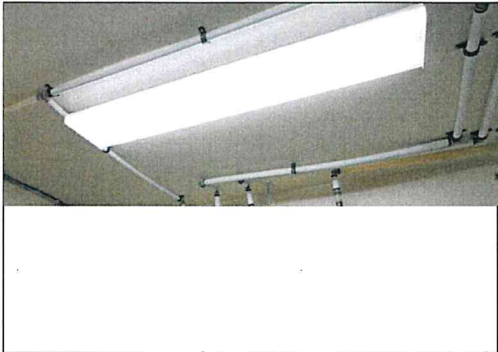
<p>Typical Common Area Fluorescent Light</p>

- Replace existing fluorescent luminaires with LED systems as renewals occur.
- Consider replacement of the exterior alarm enunciator in approximately 5 years.

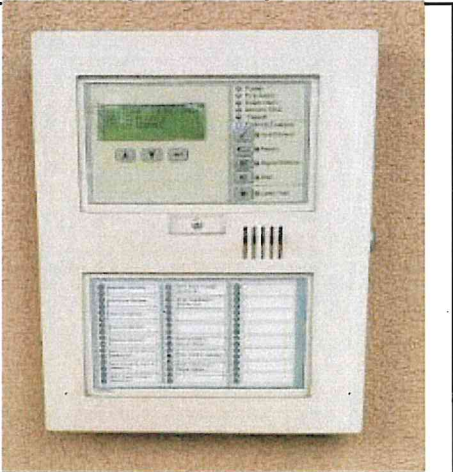
<p>Exterior Fire Alarm Annunciator at Main Entrance</p>

Condition	Remaining Life	OPC	D7050.1 Fire Alarm System	Good	10+ Years \$ 7,500.00	D7050.2 Fire Alarm Remote Annunciator	Fair	5+ years \$ 2,000.00
Condition	Remaining Life	OPC									
D7050.1 Fire Alarm System	Good	10+ Years \$ 7,500.00									
D7050.2 Fire Alarm Remote Annunciator	Fair	5+ years \$ 2,000.00
