COUNCIL REPORT  
Development Services  
For the August 13th, 2019 Council Meeting

DATE: July 30, 2019  
TO: Paul Gipps, CAO  
FROM: Geoff Brownlie, Building Services Manager  
Nancy Henderson, General Manager of Development Services  
RE: *Community Charter*, Section 57 Notice on Land Title  
Legal: Plan KAP26206 Lot 23 District Lot 3866 Osoyoos DIV of Yale District  
Address: 1543 Griffiths Place  
Owner: Ryan Gurney and Keilen Gurney

# Inspection Report

**Address:** 1543 Griffiths Place, West Kelowna, British Columbia

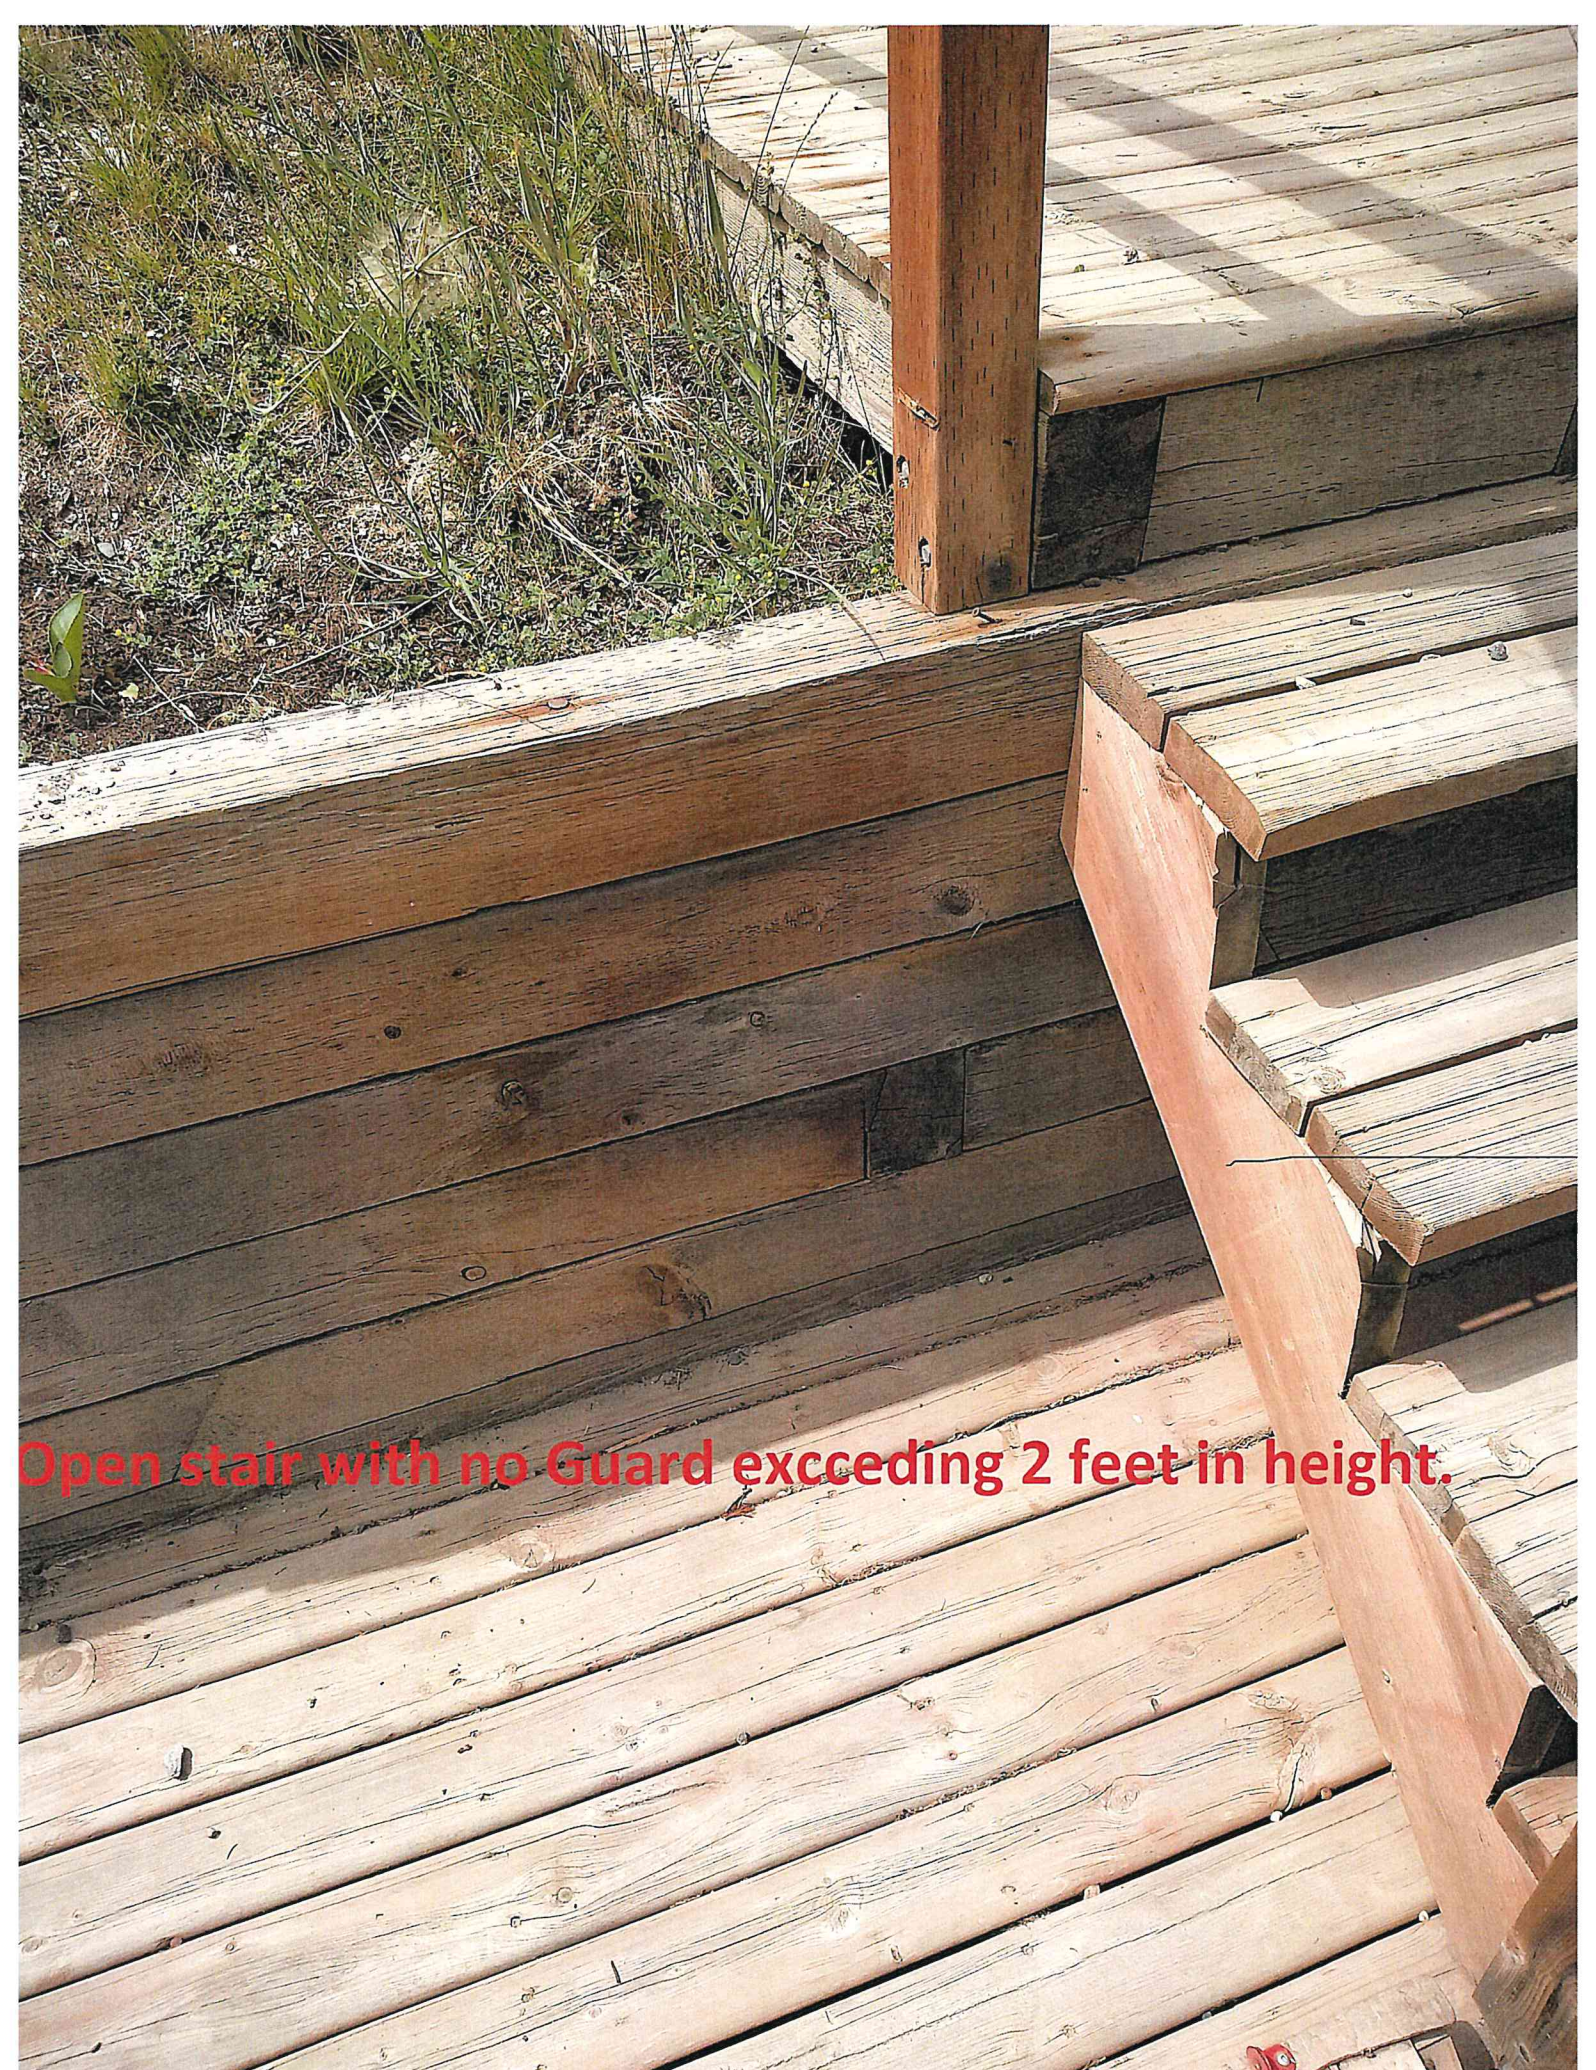
2. Guardrails – They are missing in a few locations or have not been installed correctly. The front entrance walkway and exterior stairs do not have a guardrail, and the rear built in deck seating area has opening exceeding the maximum permitted size. Elevation differences exceeding 600mm are required to be protected in accordance with Article 9.8.8.1., and openings are to limited to a maximum of 100 mm (3 7/8”) as required by Article 9.8.8.5..

8. The rear house footing appears to be exposed and does not appear to have the minimum frost protection at rear elevation under lower deck. Additional review is required to determine if there is adequate frost protection as required by Article 9.12.2.2. and the City of West Kelowna Bylaw 086 item 4.2..

**Open stair with no Guard excceding 2 feet in height.**

Foundation footing exposed - inadequate frost protection minimum 2 feet of coverage required

**Incorrect damp proofing installation & finish  
material not approved for contact below  
grade (possible structural earth load on  
wood frame wall)**

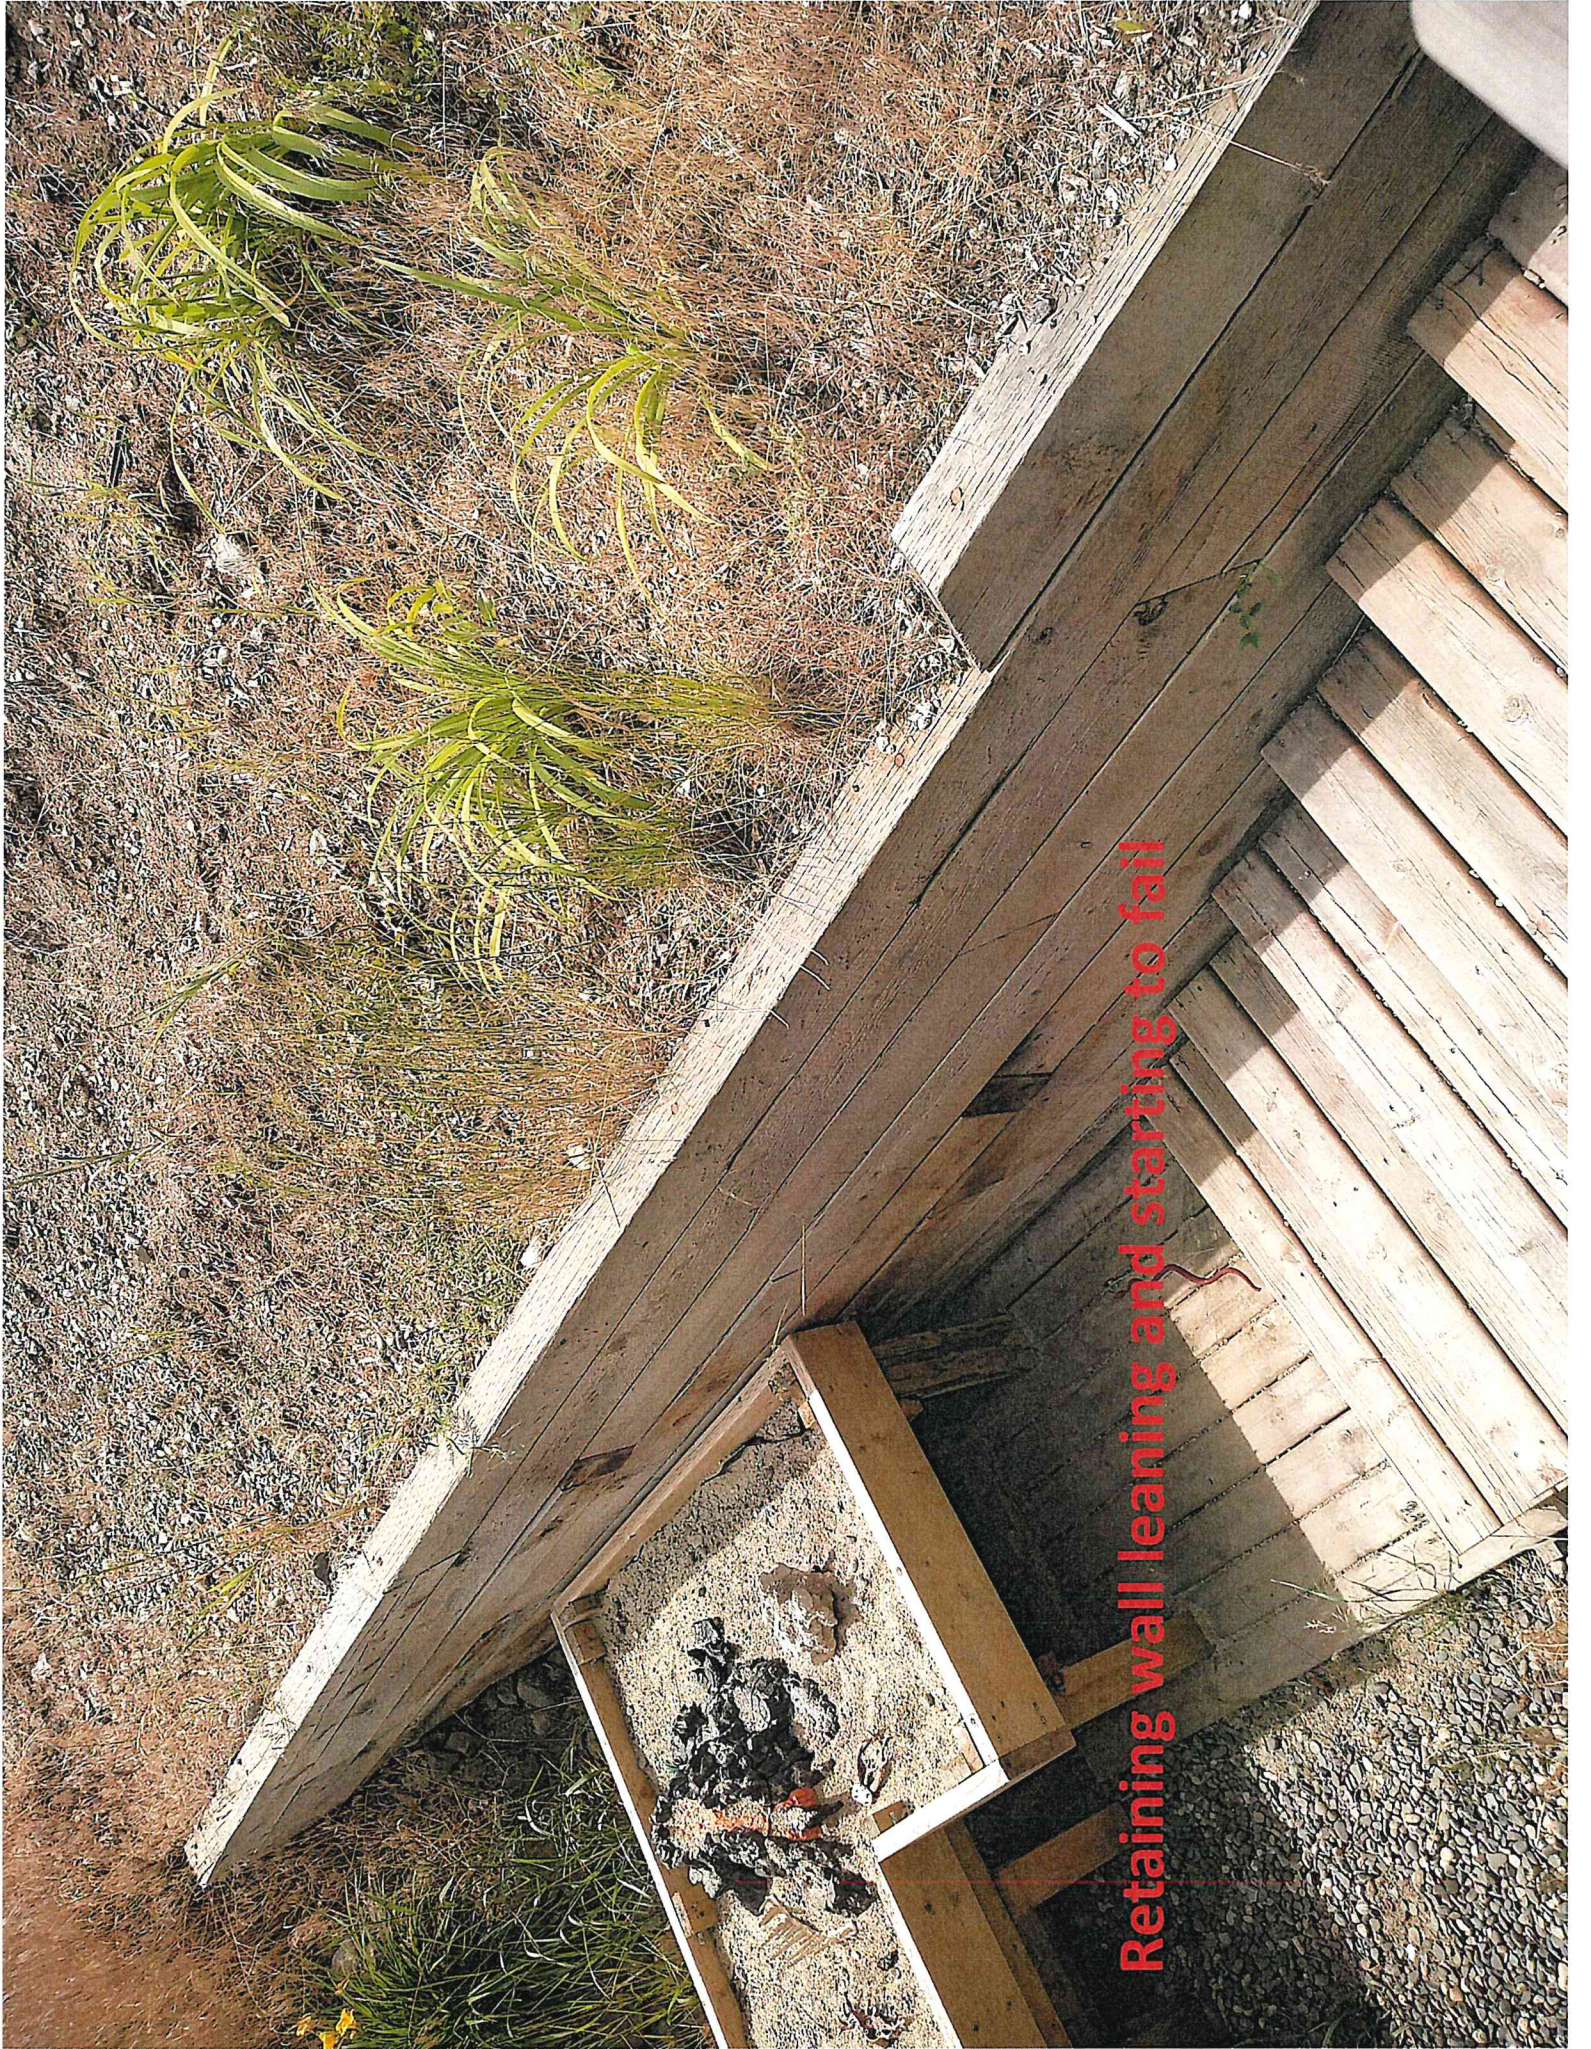
3. Front retaining walls – The front retaining walls have been constructed and show signs of bulging and failure. Retaining walls are required to be designed to resist the lateral pressure of the retained material pursuant to Article 9.4.4.5..

Pictures shared by Counsel from the time of the construction also show that there are concentrated loads from the retaining wall now applied to the foundation of the home. These concentrated loads would exceed the prescriptive requirements for the uniform loads assumed for the original construction. Loads exceeding the prescriptive requirements are to be designed in accordance with Part 4 as required by Article 9.4.1.1., and with Professional Involvement as outlined by Clause 2.2.7.1.(1)(c) of Division C.

Retaining wall leaning and starting to fail
