**ENVIRONMENTAL IMPACT ASSESSMENT
AND MANAGEMENT PLAN
FOR PROPERTY REDEVELOPMENT
At 657 Westside Road, West Kelowna**

**Report Prepared for:
Karen Lobello, owner**

**Brian Jantz, R.P.Bio, QEP
July 2020**

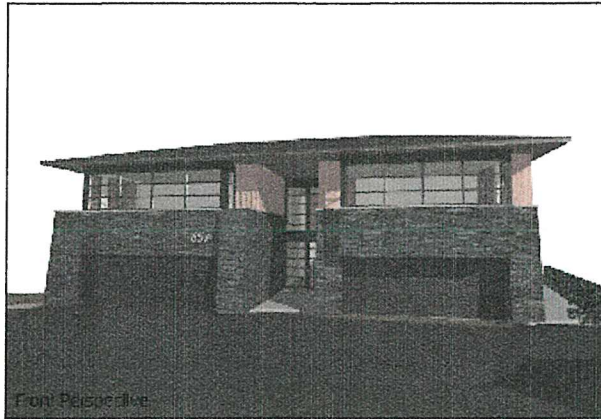
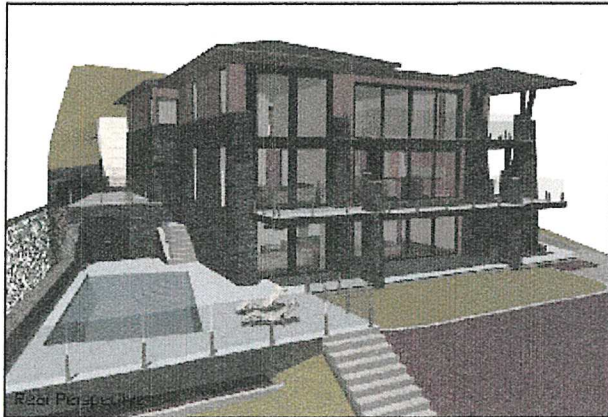
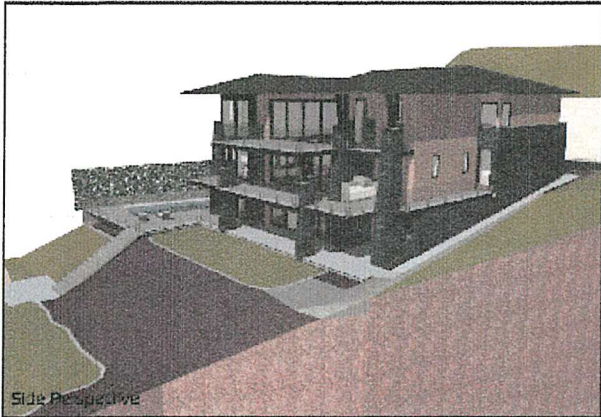
Architect
Lobello Residence
A-000

Figure 8. A concept view of the new development plans.

Figure 6 provides detail of the proposed new home redevelopment. The project designer has proposed a rebuild of the existing home which will remain outside of the present 15m setback. Home design features are provided in Figures 6 and 8 with more detailed development features shown in the Aquatic Development Permit application. All home development will take place from the driveway located above the existing home and machinery will not need to encroach into the setback.

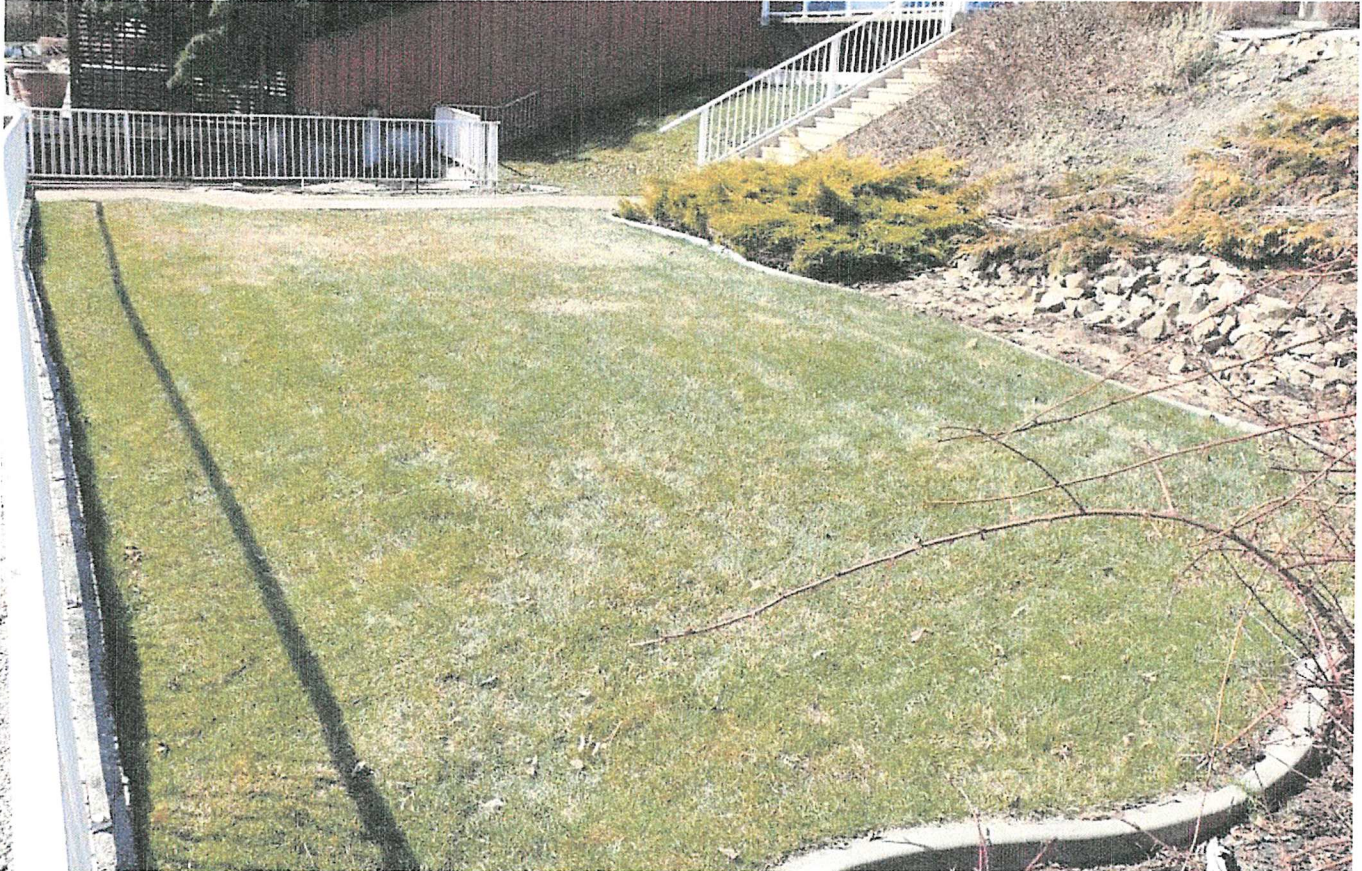
Photo 1. A view of the lower grass level next to the lakefront retaining wall. It is proposed that this lawn area be removed and planted with native trees and shrubs.

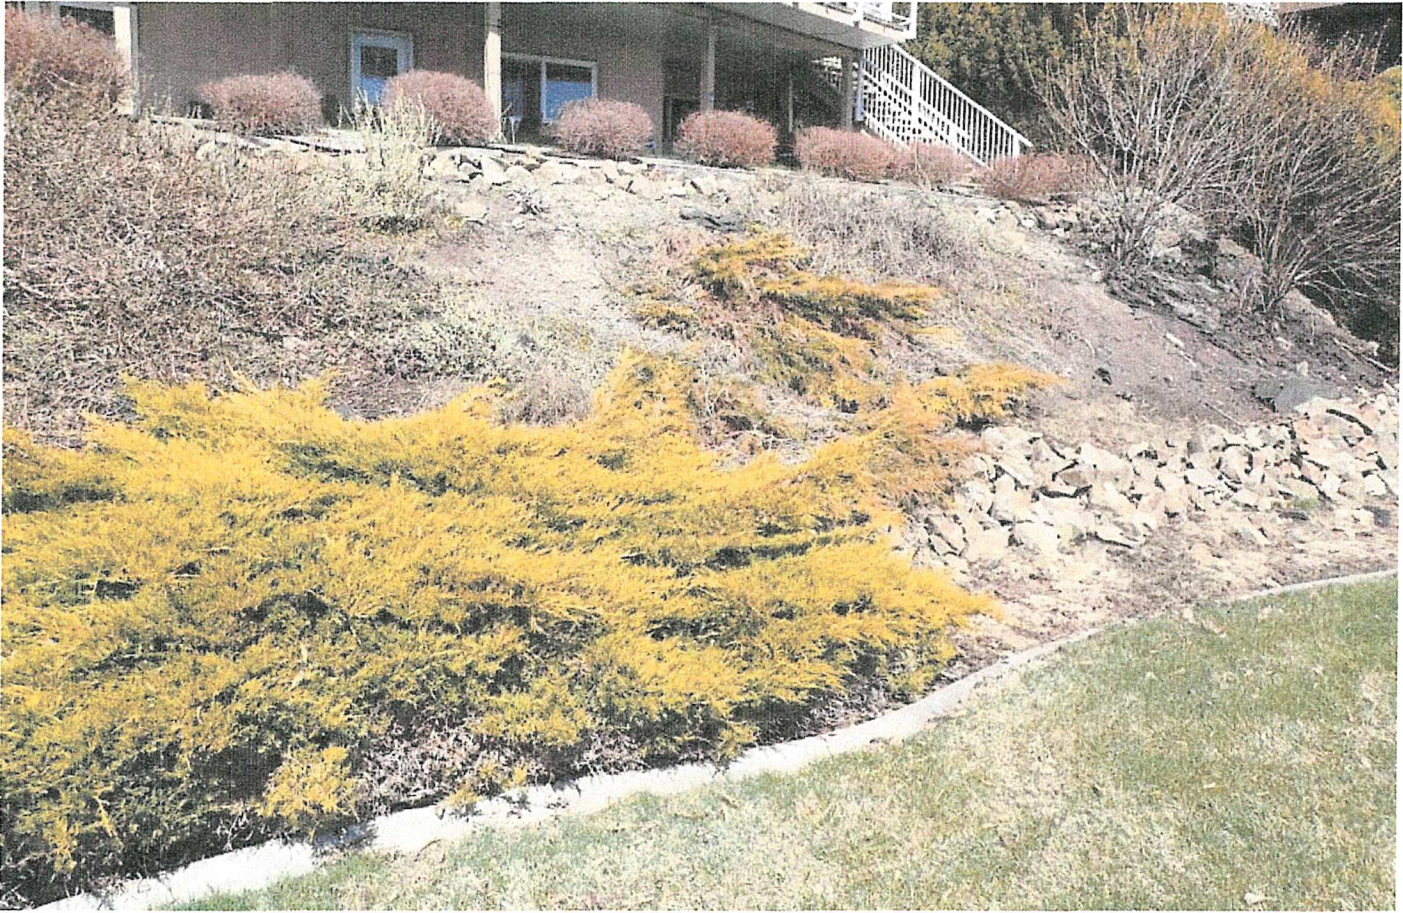
Photo 2. A view of the front bank which extends from the home level down to the lower grass level. It is proposed that this bank and adjacent lower lawn be planted with native shrubs.

A steep embankment extends from the lawn area at the frontage of the existing home down to a level area of lawn at the lakefront. This bank consists of loose soil materials and has proven to be a difficult area to maintain in terms of maintenance of plants and erosion. The top of bank is presently lined with a row of shrubs and a few juniper shrubs have survived along the rock frontage. Landscape management is difficult here because of the steep gradient and loose materials.

The property currently has a steep bank located between the upper and lower lawn areas located approximately midway within the SPEA setback. This bank is difficult to maintain because of its steep slope which consists of loose erodible materials. It is proposed that the slope and the lower lawn area located between the steep bank and the lower lakeshore retaining wall be planted with shrubs and trees. This treatment will also be extended to the lawn area located on the bank between the pool deck and the lakeshore retaining wall. This landscape plan will provide an area of 170 sq.m. of native planting beyond what currently exists and will provide a total of 105 additional trees and shrubs.

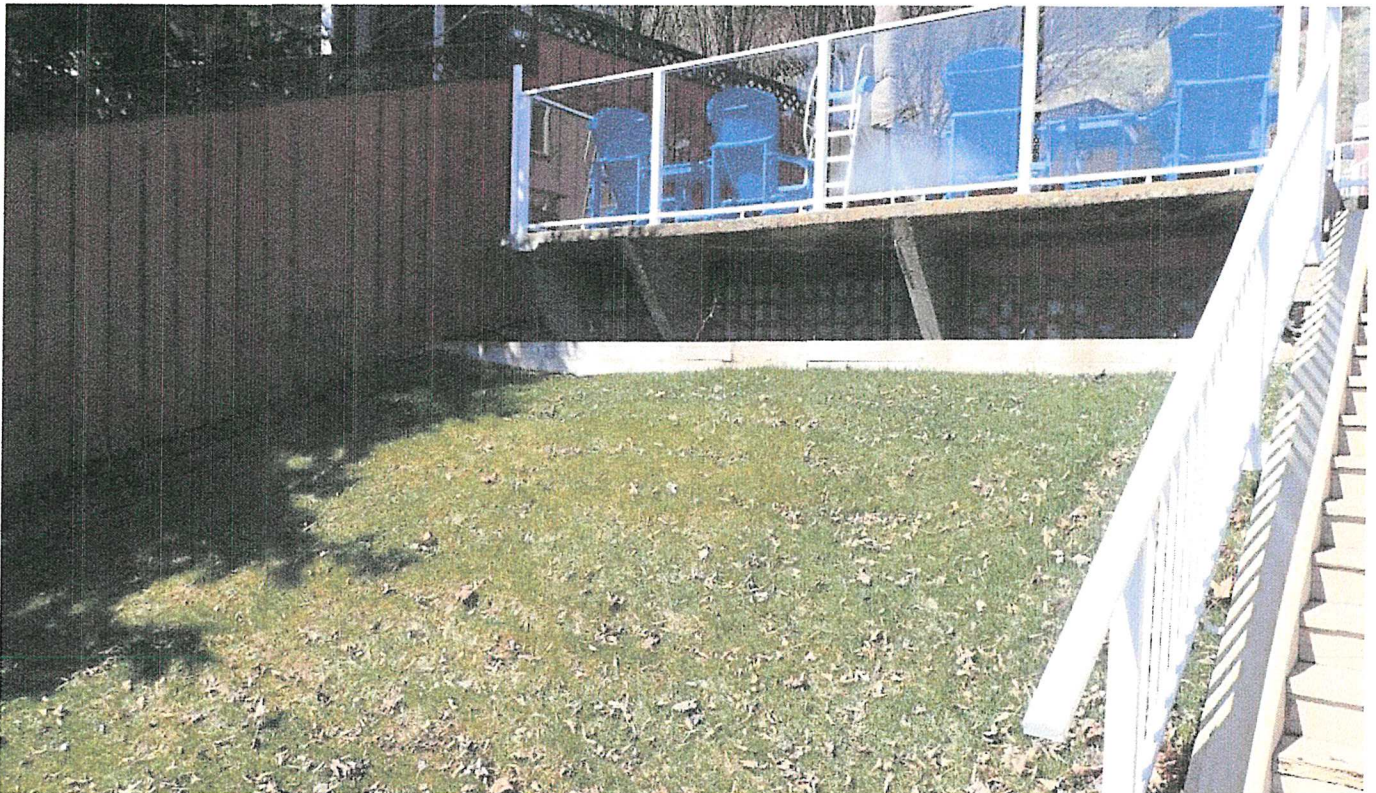
Photo 5. A view of the area below the pool on the south side of the stairs. It is proposed that this grass bank will also be planted with native shrubs.

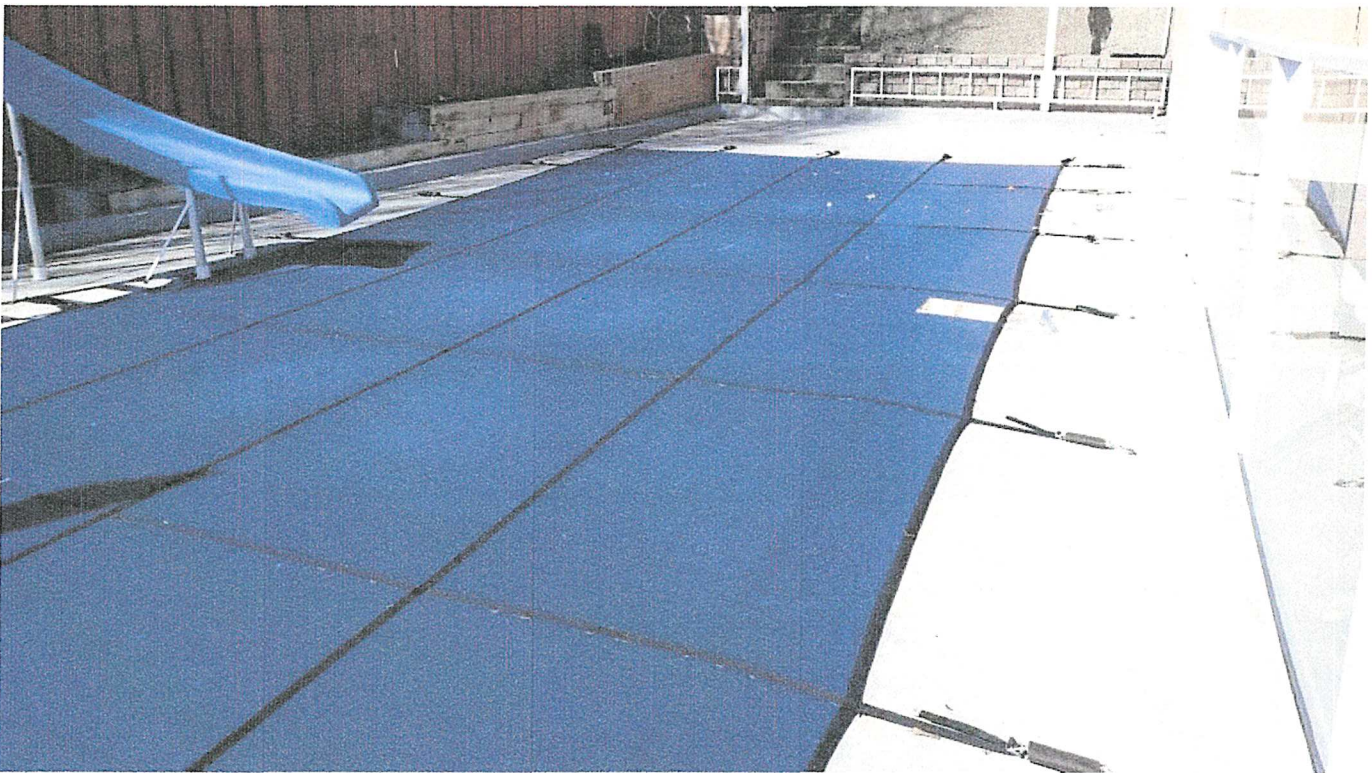
Photo 6. The owners have proposed an expansion of the pool which will extend away from the 15m setback towards the far end of the photo. The pool will be realigned with the house and formed with new concrete.

It is proposed that the pool which currently extends into the 15m setback as a grandfathered feature will be redesigned and replaced. The existing pool base is cracked and leaking and the pump system, which is currently located at a higher elevation than the top of pool does not function properly. The developer has proposed a rebuild of the pool with concrete and a slight realignment of its location. A portion of the pool will be extended towards the rear of the property within the existing deck to an area outside of the SPEA. Details are shown in Figure 6. As part of this realignment it is proposed that a gabion retaining wall be located along the southern boundary of the property which will help support the pool deck area. This pool replacement is not expected to have any negative impact to the existing pool deck area or SPEA. The

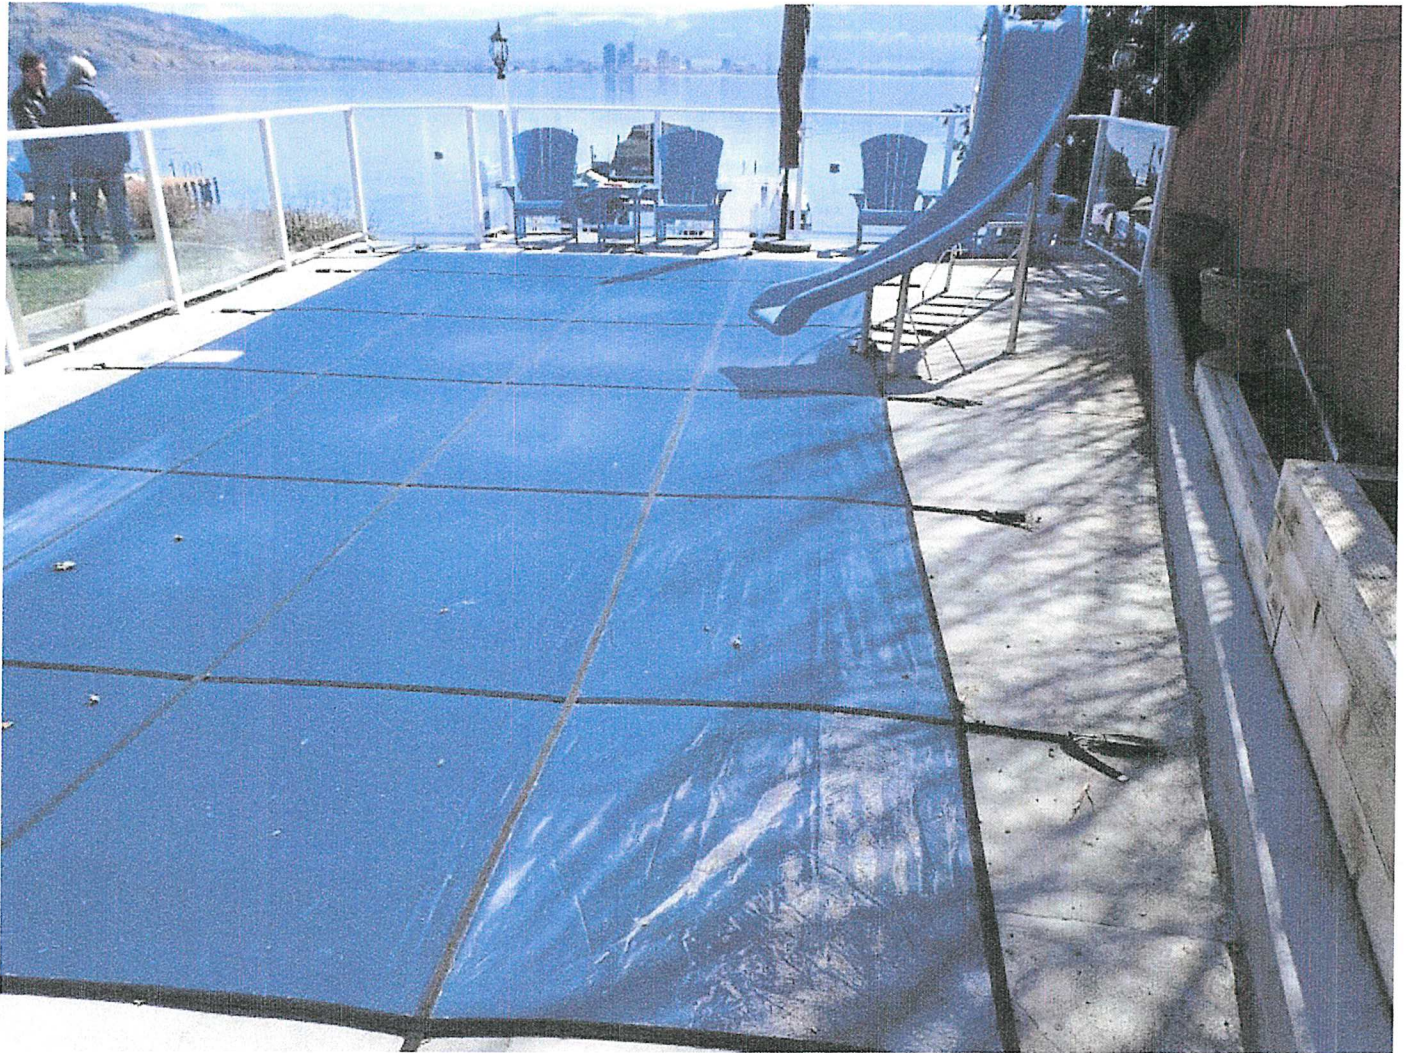
Photo 7. A view of the pool deck showing the current design. The proposal is to realign the pool with the property edge on the right and extend the pool area to the forefront. The wooden retainer along the right of the photo will be replaced with a rock gabion structure which will support the edge of the new pool.

The pool deck is a QEP determined grandfathered concrete structure located along the southern edge of the existing home. The 15m setback as determined by a jog in the lower retaining wall extends through this deck area and crosses the centre area of the pool. The pool deck therefore is a grandfathered feature which extends partly into the SPEA. This pool is in need of repairs as described later in this section. A wooden staircase also extends from the upper pool area to the lower level of the property frontage. This staircase is in need of repairs which are also discussed later in this section.

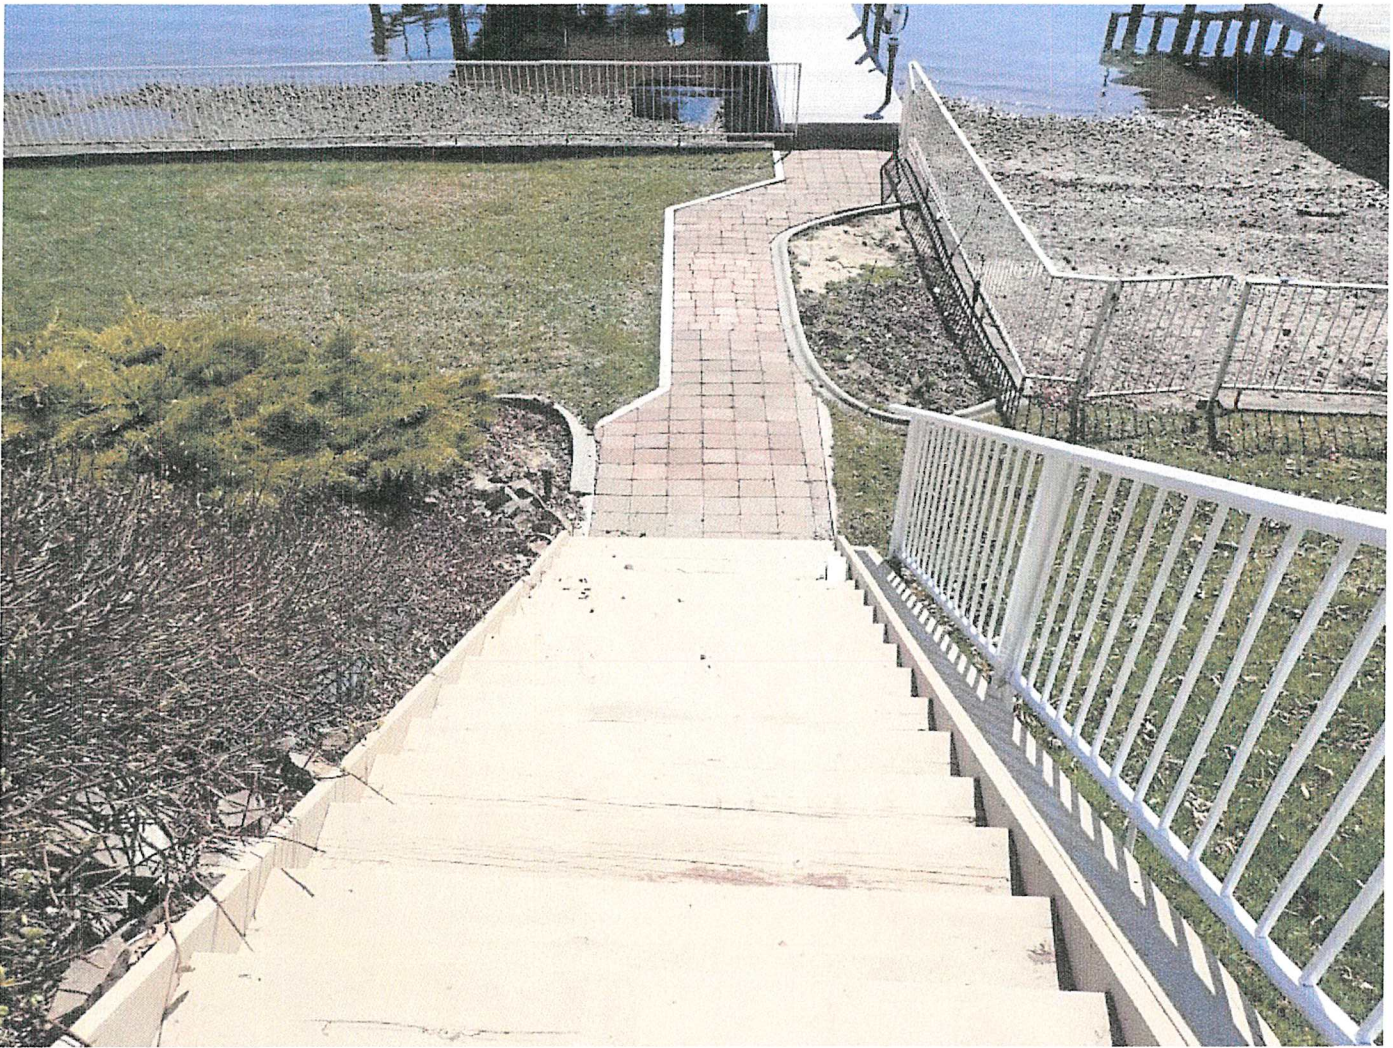
Photo 8. A view of the wooden staircase which connects the upper pool deck to the lower dock level. The proposal calls for a redesign of the wooden staircase which will be replaced with concrete slab steps placed into the bank and shifted slightly to the left of the existing steps in the photo. The tile connecting the pool will also be replaced with a new tile design. The grass area to the right of the railing will be replanted with native vegetation consisting of shrubs.

It is proposed that the wooden stairway, located between the pool upper deck and the lower property lakefront level be replaced. This stairway provides access to the lower lawn area and dock, is a grandfathered feature and is in need of repair. The designer has proposed a replacement step system consisting of pre-cast concrete slabs which will be set into the bank at a location slightly offset from the existing staircase. This new alignment will provide an improved, safer, and more permanent route to the dock area. The area of removal for the existing wooden steps will be planted with native shrubs along with the bank area leading towards the lake from the pool deck. The landing of the new step system will consist of permeable landscape tiles which will allow drainage, prevent pooling of water and allow for easy maintenance.
