COUNCIL REPORT
Development Services
For the May 28, 2019 Council Meeting

DATE: May 21, 2019 File: PRSTR20190177
TO: Jim Zaffino, CAO
FROM: Jason Sandberg, Development Engineer
RE: Application: Strata Building Conversion
Legal: Lot 1, DL 5057, Plan KAP41637
Address: 2311 Carrington Road
Owner: Sunlake Construction LTD.
Agent: Ron Knight, CFO Sunco Drywall LTD.

Brava Building 2

Building Condition Assessment

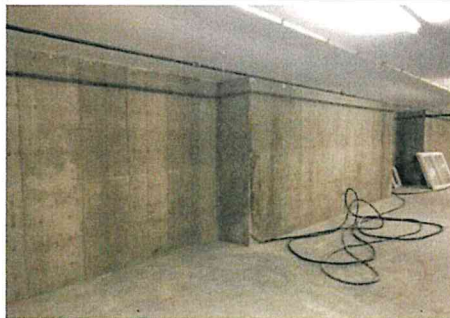
<p>Overview. Concrete Wall</p>

<p>Crack in Concrete Header Over West Interior Basement Door.</p></div>	<div><p>Description</p><p>Brava Building 2 includes a full below grade level. The perimeter foundation consists of cast-in-place, conventionally reinforced concrete walls bearing on strip footings. Interior and exterior columns bear on spread footings.</p><p>The basement floor is a concrete slab-on-grade.</p></div> <div><p>Assessment</p><p>No evidence of distress was observed. Minor cracking in the concrete was observed in a concrete header beam over the west basement interior door. The crack should be monitored for changes in crack width.</p><p>Some cracks were observed in the slab-on-grade. Cracks were adjacent to saw cuts, suggesting that saw cutting was completed after tensile stresses in the concrete had developed. Cracks are not a structural concern for a slab-on-grade and should be monitored for aesthetics/trip hazards.</p></div>

Recommendation		Condition	Remaining Life	OPC
A1010.1 Foundation Condition. Monitor crack in header		Good	Greater than study extent	Less than Threshold
A1010.2 Slab-on-Grade. Monitor aesthetics / trip hazards due to cracks.		Good	Greater than study extent	Less than Threshold

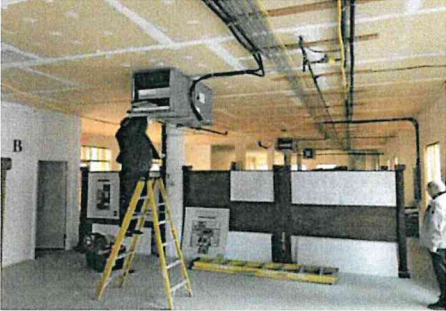
<p>Interior View at Ground Floor. Structure Obscured by finishes.</p>

<p>Cracking in Ground Floor Concrete Topping.</p>	<p>Description</p> <p>The structure is wood-frame construction. Ground and upper floor framing consist of concrete topping on plywood sheathing on engineered wood joists spanning to wood beams and perimeter walls.</p> <p>Roof structure consists of sheathing on engineered roof trusses spanning to load bearing walls.</p> <p>Load bearing walls consist of 2x6 studs with wood headers at window and door openings. Walls are sheathed to provide lateral capacity.</p> <p>Roof overhangs at the south elevation of the ground floor and at upper floor balconies are supported on perimeter columns.</p> <p>Assessment</p> <p>Visual review of the superstructure found no evidence of distress. Superstructure framing is concealed by interior and exterior finishes and not directly visible.</p> <p>RJC observed some cracking in the concrete topping of the ground floor. It appears that the cracking is related to drying shrinkage and, in our opinion, is not a structural concern. The ground floor was un-finished at the time of RJC's review.</p> <p>Ground floor column caps are pressed concrete. Consideration should be given to application of a coating to prevent water ingress and improve long-term durability.</p>

RJC observed some cracking in the concrete topping of the ground floor. It appears that the cracking is related to drying shrinkage and, in our opinion, is not a structural concern. The ground floor was un-finished at the time of RJC's review.

Recommendation		Condition Remaining Life OPC
B1010.1	Add moisture protection to column caps to improve durability	<div>Good</div> Greater than study extent \$ 5,000.00

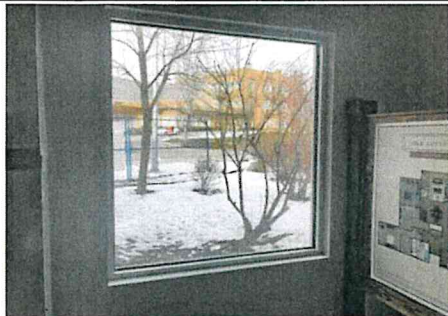
<p>Typical Ground Floor Window. Aluminum Frame. Interior View</p>

Recommendation		Condition	Remaining Life	OPC	
B2020.1	Aluminum frames and windows.	Good	Greater than extent of study.	No Recommendations	
B2020.2	Vinyl frames and windows	Good	Greater than extent of study.	No Recommendations	
B2020.3	Replace three cracked IGUs	Failed	N/A	Maintenance

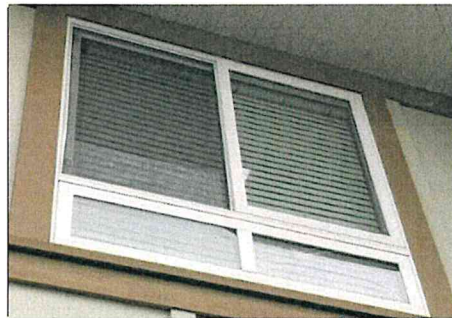
<p>Typical Upper Floor Window. Vinyl Frame. Exterior View</p>

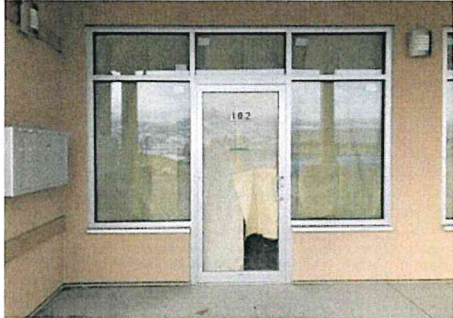
<p>Typical Ground Floor Unit Entry Door, Aluminum Frame.</p>

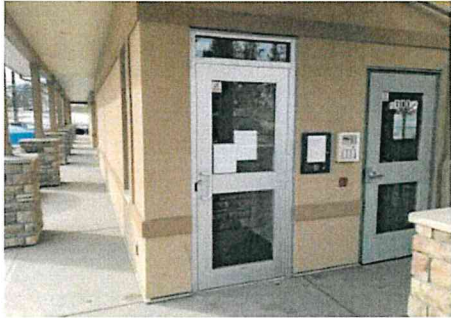
<p>Ground Floor Aluminum Frame Door (Left) and Metal Frame Door (Right)</p>

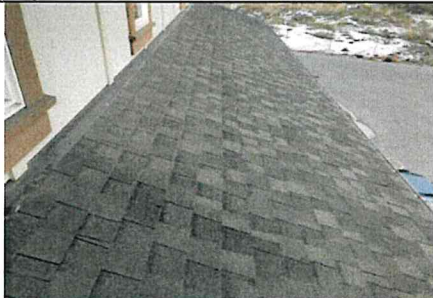
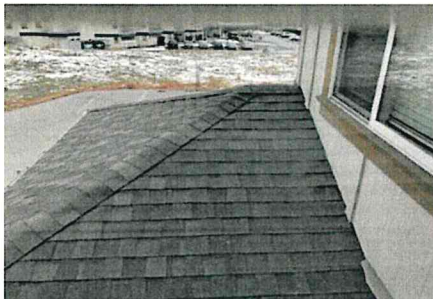
Description Roofing is specified as fibreglass asphalt shingles on asphalt building paper with eave and valley protection and galvanized metal drip edge.			
	Typical Condition. Asphalt Roofing Shingles

Assessment Roofing was generally found to be in good condition.			
	Typical Condition. Asphalt Roofing Shingles				
	Recommendation		Condition	Remaining Life	
B3010.1 Roofing.		Good	Greater than extent of study.	No Recommendations

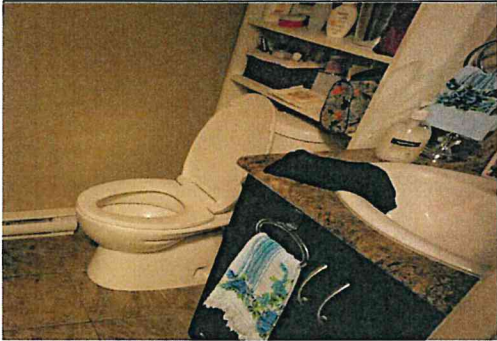
<p>Typical Suite - Washroom Fixtures</p>

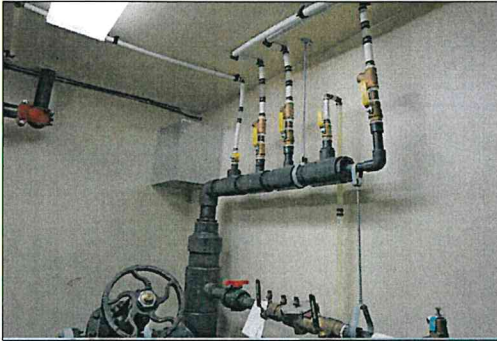
<p>Domestic Water Distribution Header</p>

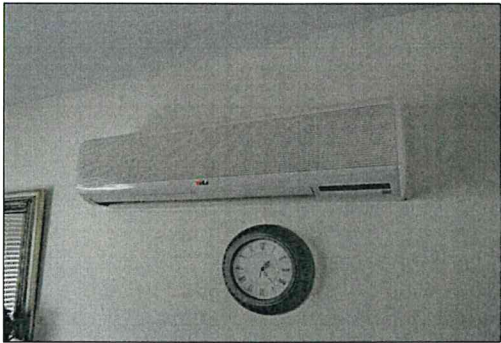
<p>Direct Expansion Fan Coil Unit - Split AC System</p>

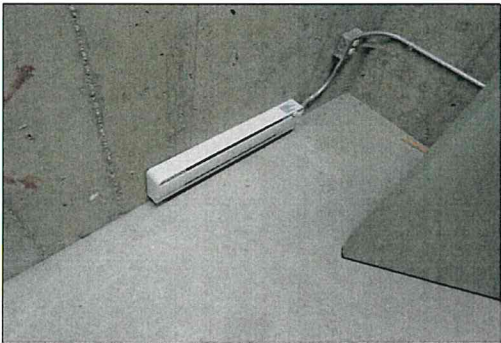
<p>Electric Heat - Baseboard</p>	<p>Description</p> <ul style="list-style-type: none"> • Heating and cooling for each of the three (3) main floor commercial suites is provided by a split direct expansion fan coil unit (indoor) coupled with an air source heat pump(outdoor). • Cooling for each of the three (3) second floor residential suites is provided by split direct expansion wall cassette fan coil unit (indoor) coupled with an air source condenser (outdoor). • Heating for second floor residential suites is provided by electric baseboards and gas fireplaces. • Heating in ancillary spaces, stairwells, and basement is provided by electric baseboards and electric unit heaters. <p>Assessment</p> <ul style="list-style-type: none"> • No upgrades are anticipated at this time. 												
<p>Recommendation</p> <p>D3010.1 Split Heat Pump Systems - Replace or repair as required. (Note: OPC is for each unit)</p> <p>D3010.2 Split AC Systems - Replace or repair as required. (Note: OPC is for each unit)</p> <p>D3010.3 Electric Heat (Unit Heaters and Baseboards) - Replace as required. (Note: OPC is for each unit)</p>

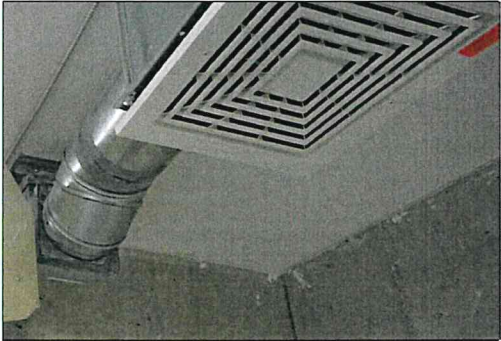
<p>Basement Exhaust Fan</p>	<p>Description</p> <ul style="list-style-type: none"> • Ventilation for second floor residential suites is provided by operable windows (natural ventilation) in combination with bathroom exhaust fans. • There is no outdoor air provided for the main floor commercial suites. • Ventilation for the basement is provided by louvres on the main floor ducted down to the basement in combination with exhaust fans. <p>Assessment</p> <ul style="list-style-type: none"> • No upgrades are anticipated at this time.

<p>Outdoor Air Louvre</p>	
Recommendation		Condition Remaining Life OPC
D3020.1	Exhaust Fans - Replace or repair as required. (Note: OPC is for each unit)	Very Good 16 \$ 500.00

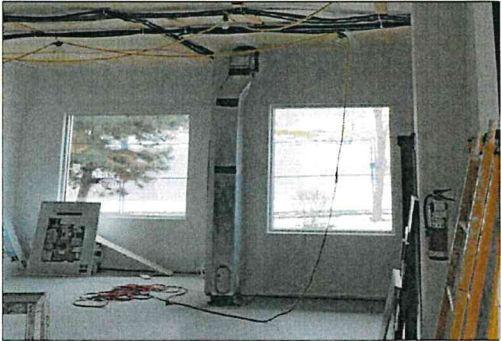
<p>Outdoor Air Ventilation Duct to Basement</p>

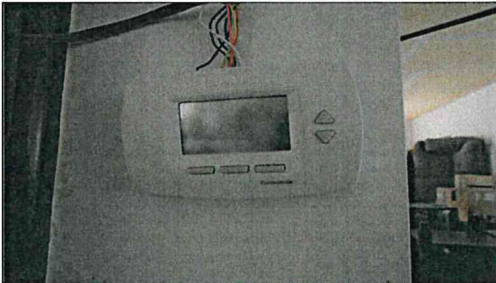
<p>Programmable Thermostat</p>

<p>Standard Thermostat</p></div>	<p>Description</p> <ul style="list-style-type: none">The HVAC control systems are based on programmable and standard thermostats.			
		<p>Assessment</p> <ul style="list-style-type: none">No upgrades are anticipated at this time.			
Recommendation		Condition	Remaining Life	OPC	
D3030.1 Thermostats - Replace as required.		Good	5 to 10 years	\$	100.00

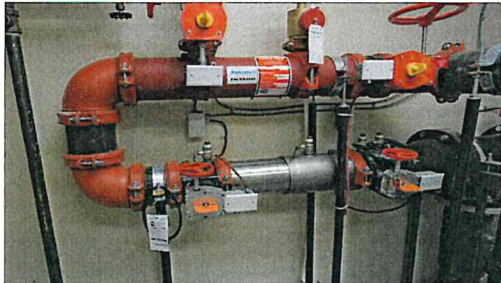
<p>Sprinkler Tree - Basement Mechanical Room</p>

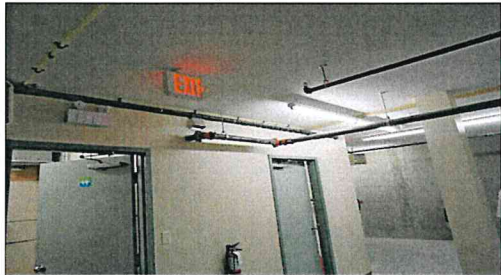
<p>Fire Sprinklers - Basement Only</p>

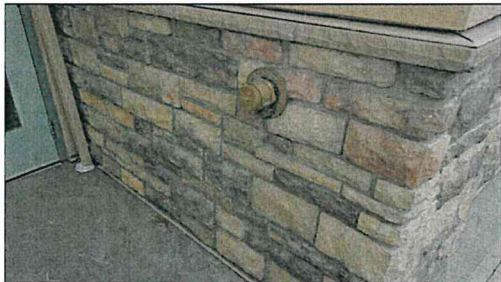
<p>Fire Department Connection</p>	<p>Description</p> <ul style="list-style-type: none"> Fire suppression systems have been provided for this building, but only serve the basement. Provisions for a 6" connection to a future building have been provided and piped through the basement wall. <p>Assessment</p> <ul style="list-style-type: none"> No upgrades are anticipated at this time.
Recommendation		Condition Remaining Life OPC
D4010.1	Fire suppression systems - provide regular service as required.	Good N/A N/A

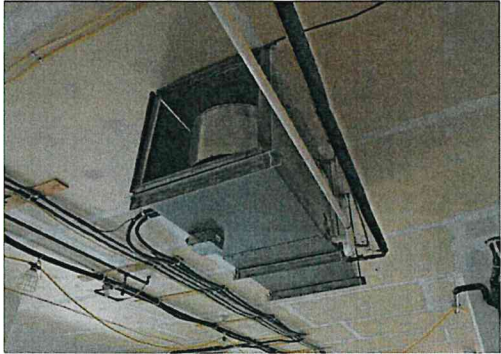
<p>Wiring to CRU Fan Coil</p>

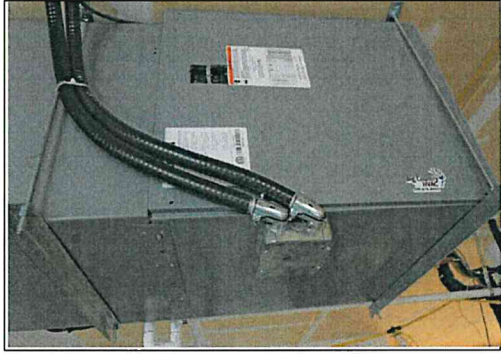
<p>Dual Feed to Fan Coil</p>

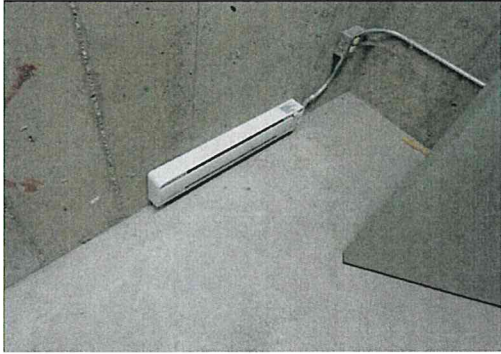
<p>Electric Heat - Baseboard</p>	<p>Description</p> <ul style="list-style-type: none"> Wiring is provided in armoured cable to the main floor air handling units and outdoor condensers from the CRU panels The residential suites are wired to electrical code requirements <p>Assessment</p> <ul style="list-style-type: none"> Wiring methods and general purpose electrical is properly installed and expected to last many years with no upgrades required. 						
Recommendation		<table> <tr> <th>Condition</th><th>Remaining Life</th><th>OPC</th></tr> <tr> <td>D5030.1 None</td><td>30+ Years</td><td>\$ -</td></tr> </table>	Condition	Remaining Life	OPC	D5030.1 None	30+ Years	\$ -
Condition	Remaining Life	OPC						
D5030.1 None	30+ Years	\$ -

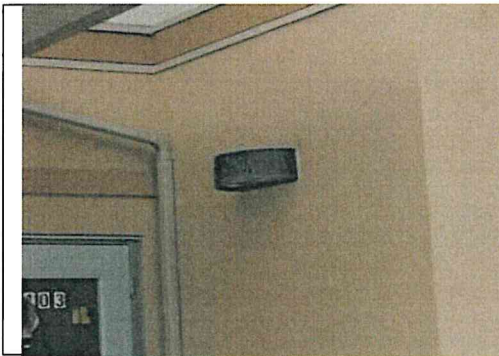
<p>Exterior HID Wallpack</p></div>	Description <ul style="list-style-type: none">• Common area lighting consists of T8 fluorescent utility lights with electronic ballasts• Suite lighting is standard surface mount residential luminaires• Exterior lighting consists of HID wallpacks and compact fluorescent pot lights			
		Assessment <ul style="list-style-type: none">• Anticipated life of the lighting equipment is in the range of 10 years. Luminaires should be replaced with LED as they fail.			
Recommendation		Condition	Remaining Life	OPC	
D5040.1 Interior Fluorescent Lighting replace as required with LED		Good	10	\$ 100.00	
D5040.2 Exterior Lighting replace as required with LED		Good	10	\$ 200.00	
D5040.3 Suite Lighting replace as required		Good	10	\$ 50.00

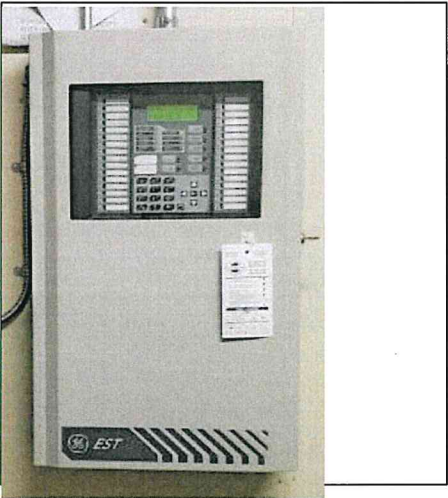
<p>Fire Alarm Panel Located in Main Electrical Room</p>	<p>Description</p> <ul style="list-style-type: none"> The building is protected by an Edwards EST addressable fire alarm panel that monitors the basement sprinkler system, pull stations at exit doors, and fire detectors in suites and CRUs. Strobes and suiter buzzers are installed as required by code. The remote annunciator is installed outdoors at the main entrance. The fire alarm system is of modern design and construction and spare parts are readily available <p>Assessment</p> <ul style="list-style-type: none"> No upgrades are anticipated at this time. 									
Recommendation
