COUNCIL REPORT  
Development Services  
For the August 13th, 2019 Council Meeting

DATE: July 30, 2019  
TO: Paul Gipps, CAO  
FROM: Geoff Brownlie, Building Services Manager  
Nancy Henderson, General Manager of Development Services  
RE: *Community Charter*, Section 57 Notice on Land Title  
Legal: Plan KAP26206 Lot 23 District Lot 3866 Osoyoos DIV of Yale District  
Address: 1543 Griffiths Place  
Owner: Ryan Gurney and Keilen Gurney

# Inspection Report

**Address:** 1543 Griffiths Place, West Kelowna, British Columbia

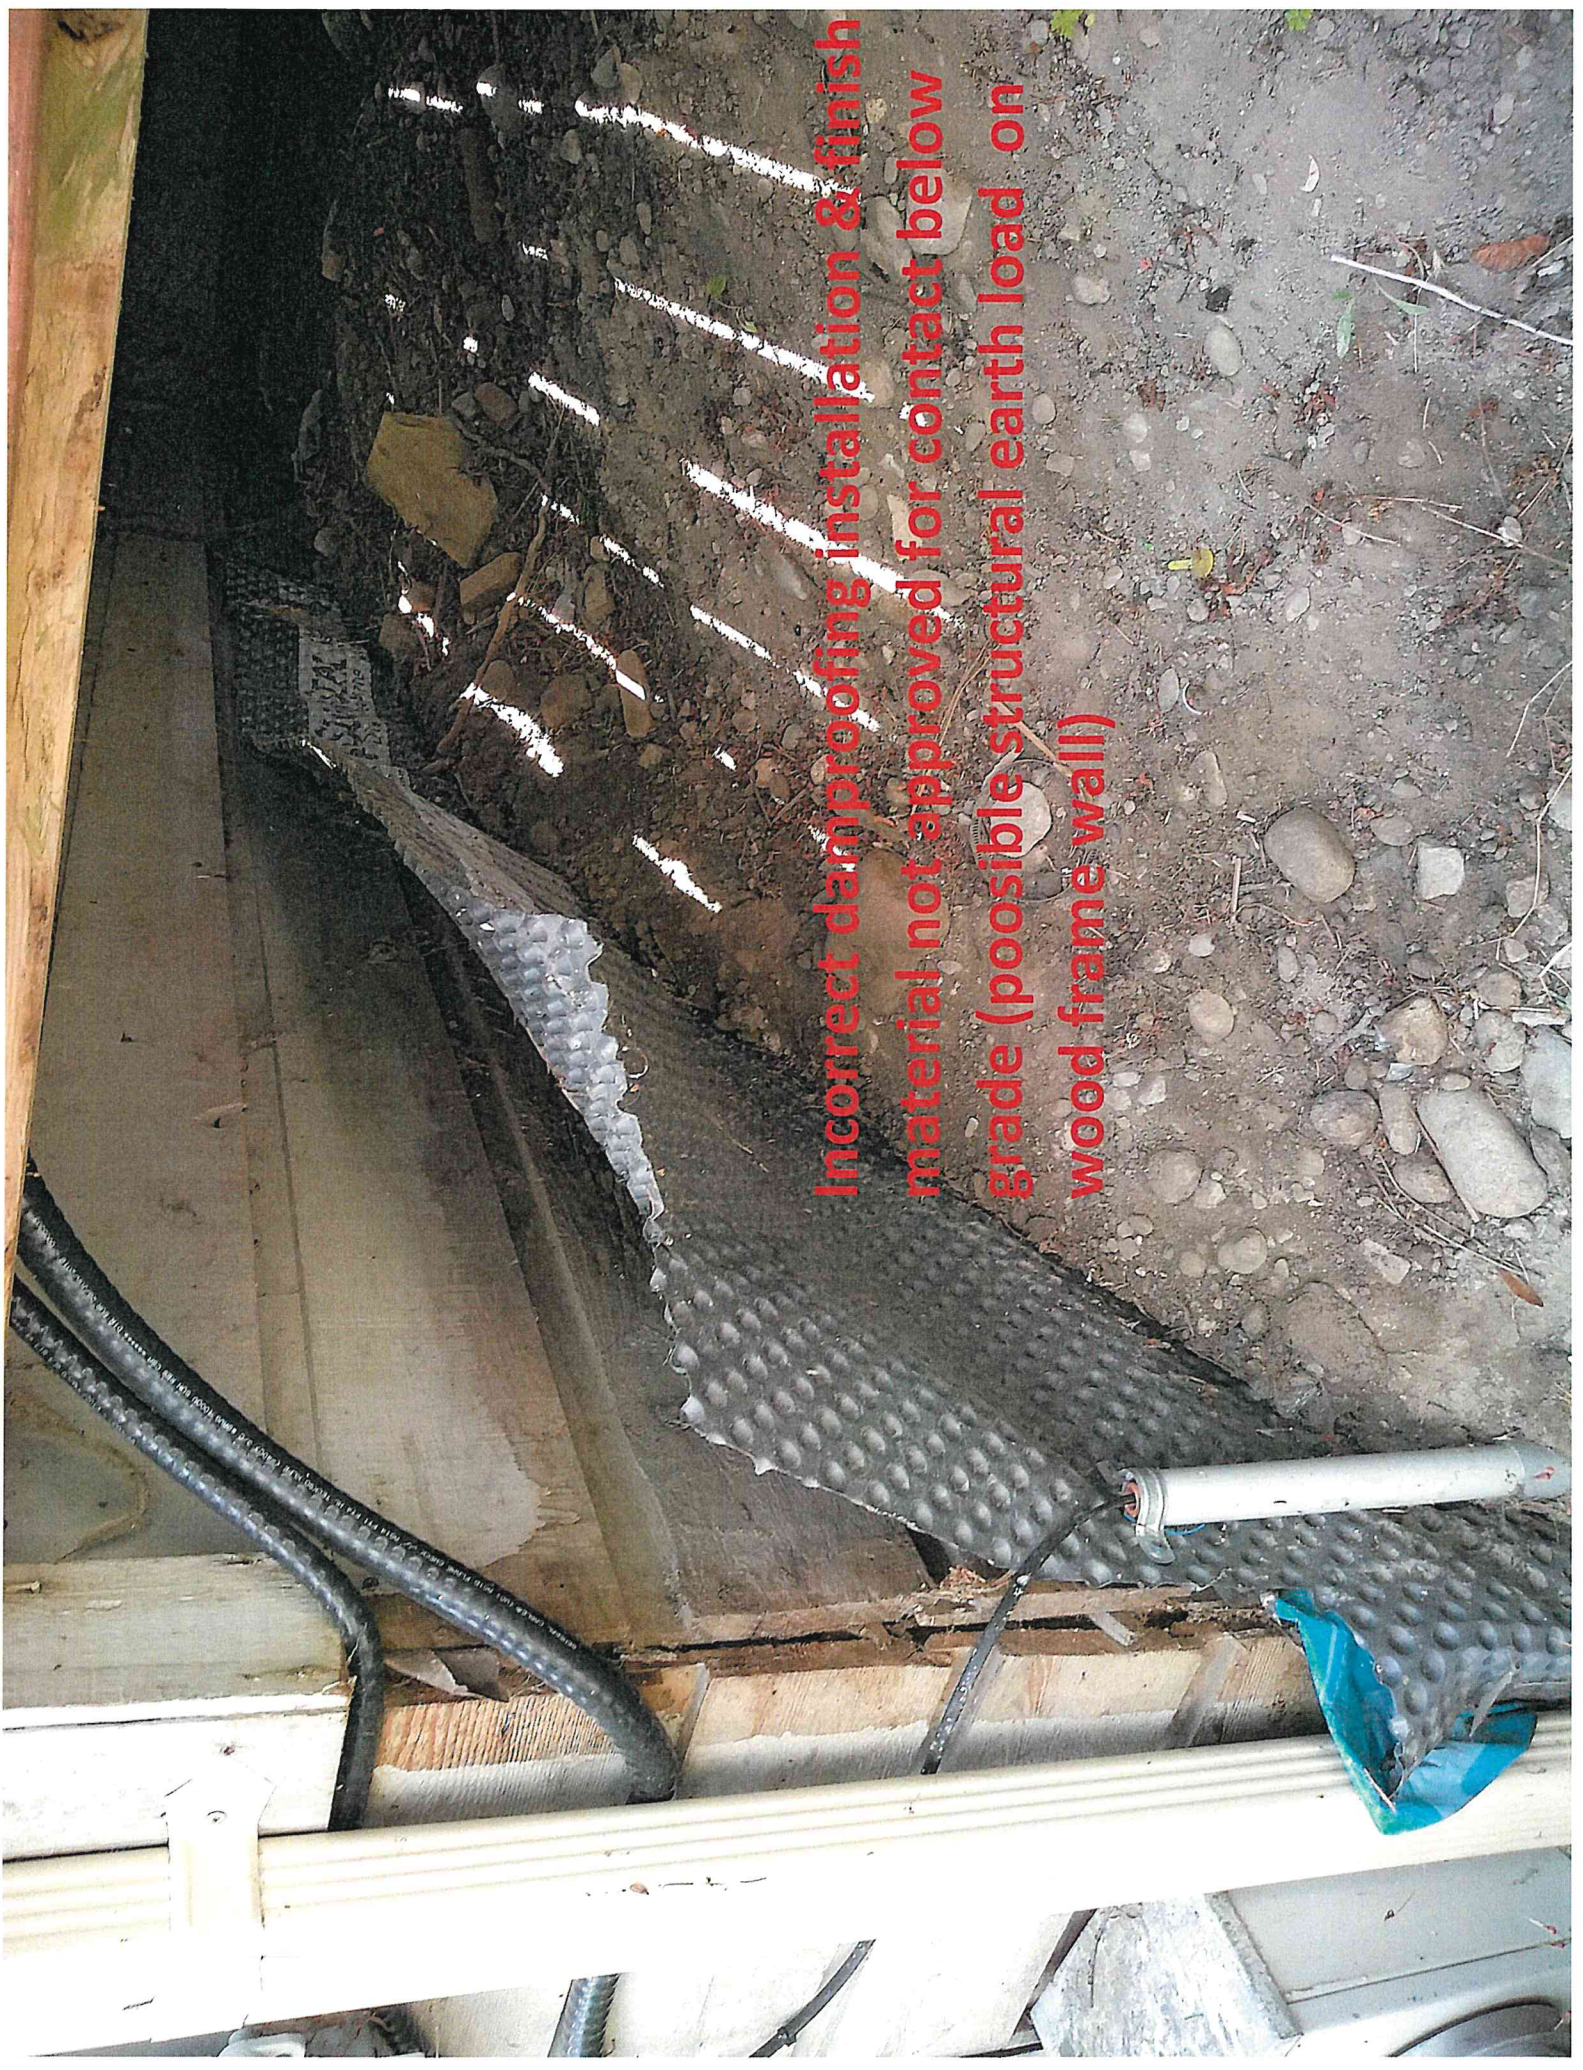
8. The rear house footing appears to be exposed and does not appear to have the minimum frost protection at rear elevation under lower deck. Additional review is required to determine if there is adequate frost protection as required by Article 9.12.2.2. and the City of West Kelowna Bylaw 086 item 4.2..

Foundation footing exposed - inadequate frost protection minimum 2 feet of coverage required

**Incorrect damp proofing installation & finish  
material not approved for contact below  
grade (possible structural earth load on  
wood frame wall)**
